## Restoring a General Electric 'Color Radio' Model K-106 – Gerry O'Hara

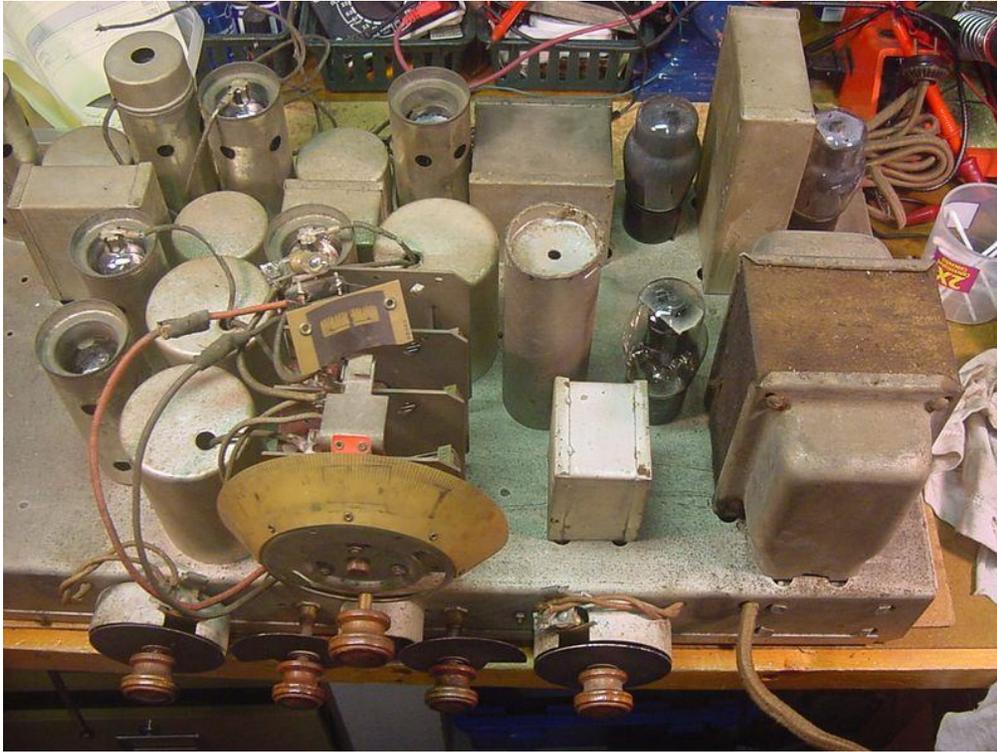
On arrival, the chassis looked very 'tired' and very dirty, with many loose and frayed wires, ancient sticky-tape covering poorly-soldered connections and crumbling rubber insulation on top-cap (grid) wires to several tubes. The chassis bore the scars of some previous repair work – many decades old judging by the components used. Where to start?

The first thing to do on a chassis in this condition is to remove all tubes and test the most expensive component is

functional – the power transformer, together with checks on the mains wiring to check it is safe to apply voltage to the set when other repairs have been effected. Coupling an AC voltmeter to the transformer HT secondary, and the primary to a Variac, the transformer

proved to be in good order (the transformer on this chassis is a very large and robust-looking unit). If the transformer had proved to be burned-out or otherwise damaged, the owner would have been contacted to advise that a replacement transformer was needed and to obtain approval before proceeding.

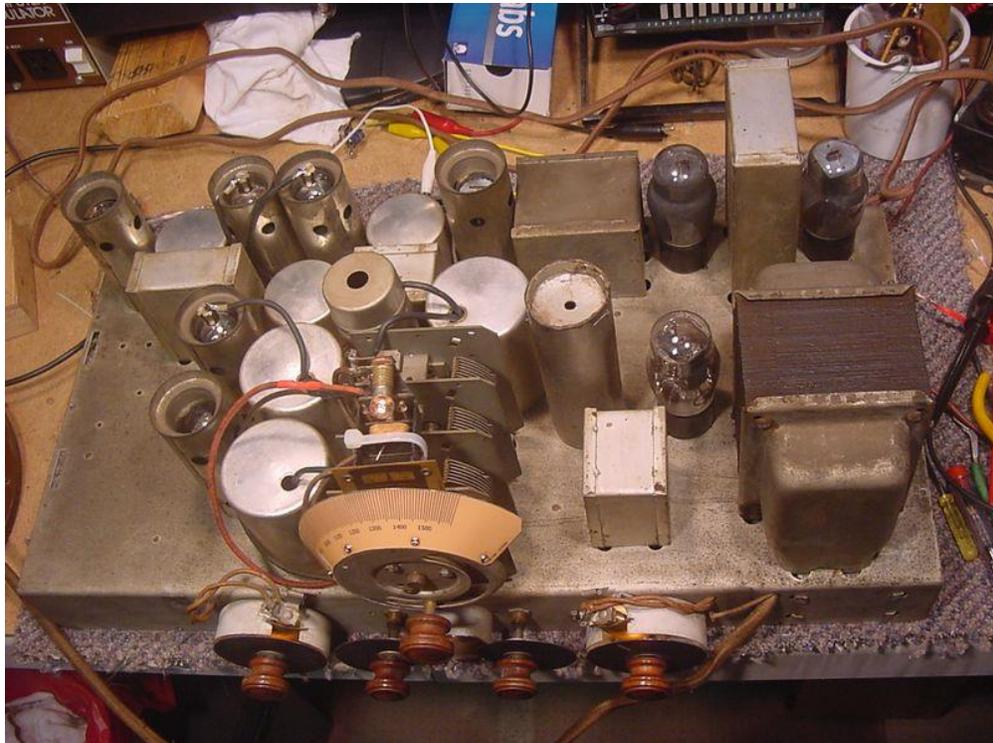
I cannot stand working on a dirty chassis, so the next job was to clean things up a bit – alcohol-soaked cloths and Q-Tips removed most of the

grime. Next, the nasty-looking tarry-paper capacitors were all replaced (all tested leaky), as was the single 10uF electrolytic (which had been replaced previously in the dim distant past). The lower-value

(mica) capacitors were tested and were within tolerance, so were left in circuit. The metal-can potted multiple capacitors were tested and two sets of these were replaced as they were all leaky (with individual capacitors, ie. the cans were left in place but not re-stuffed). The third set (twin 1uF) tested ok and was left in-circuit. Two resistors were also changed-out as these tested out of tolerance during random checking of resistors. The main tuning gang was noted to be loose – due to perished mounting grommets – these were replaced. The wires with the perished rubber insulation were covered with heatshrink sleeves. Poorly-soldered joints were repaired and insulated with heatshrink. An in-line fuseholder was

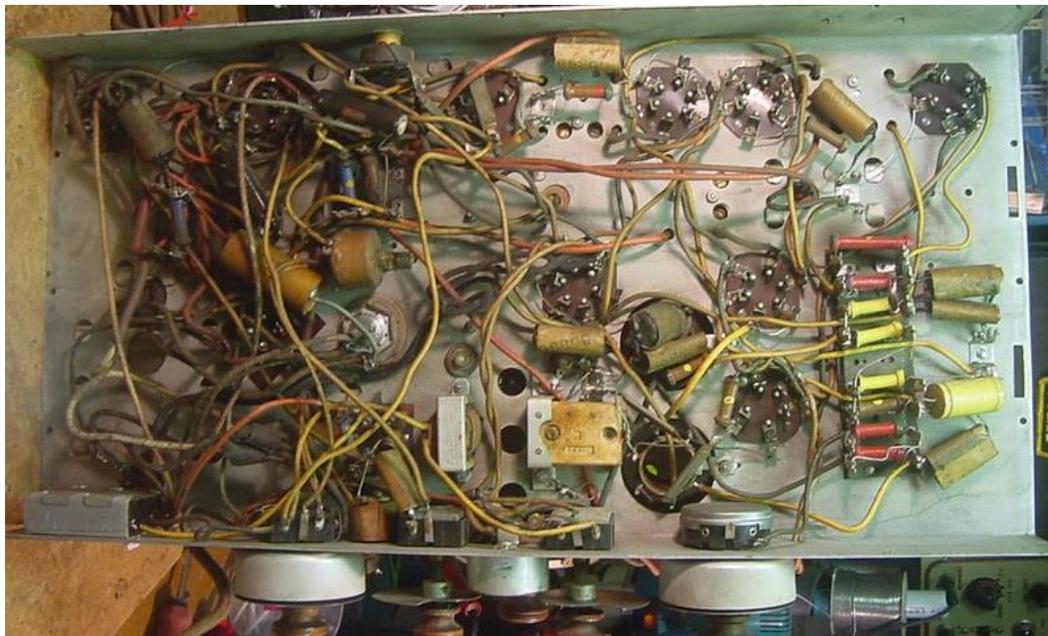
installed in the power transformer primary (2A fuse fitted). The translucent dial was very worn and a replacement had been purchased – this was fitted. The tuning meter was sticking and the needle was

bent – this was carefully straightened. All controls and the tuning gang contact points were cleaned with De-Oxit. Finally, three

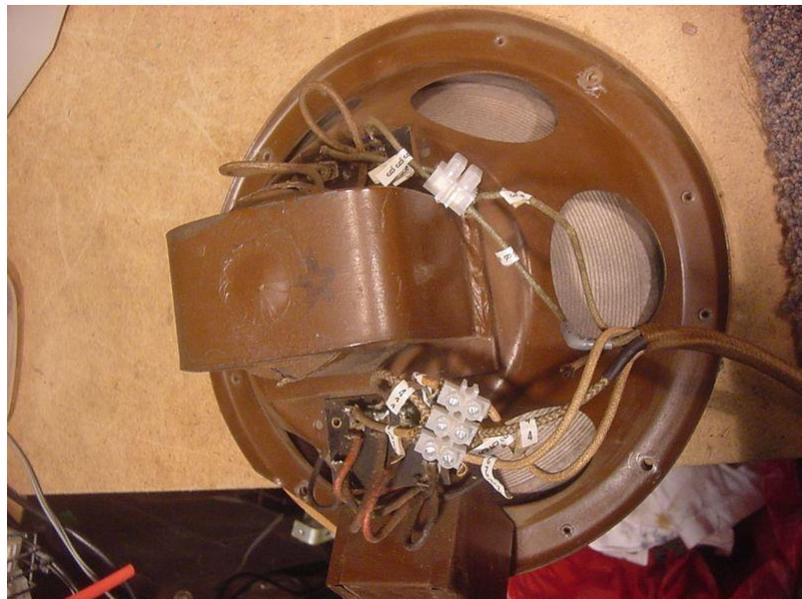
The speaker was connected using a connection block and some minor repairs to the insulation on the speaker lead was undertaken using heatshrink. The tubes were cleaned and replaced in their sockets and power applied gradually using a Variac. A DC voltmeter on the HT line measured zero: the #80 rectifier tube was cold, its heater testing as open circuit. Fitting another #80 tube soon solved the HT voltage problem, and a slight noise could now be heard from the speaker – touching the mixer tube grid increased the noise level, but no stations could be heard – I suspected the local oscillator was not working. Checking around the circuit I found there was no HT on the local oscillator (#56 tube) and the screen voltage on the RF and IF stages was also missing. This fault was traced to an open-circuit power resistor in the power supply circuit. This replaced, the set sprang to life, although the dial settings were quite a bit out. The IF (175kHz) and RF stages were aligned and the set proved to work very well indeed – including the tuning indicator.
