# Repair of a Marelli Assab Receiver – Brent Hilpert

(photos by John Sarembo)

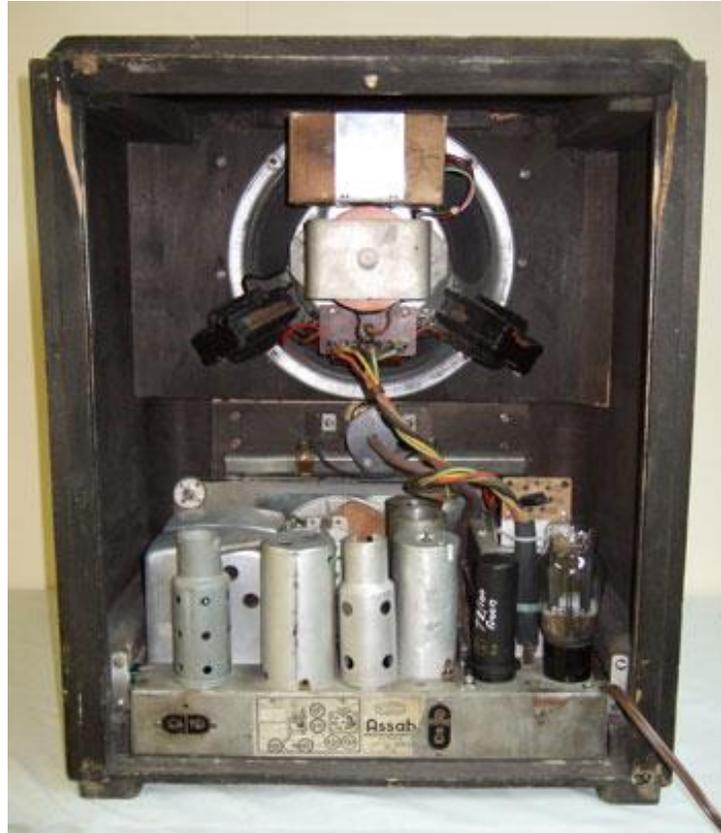
The unit had received a sharp jolt somewhere in it's travels, resulting in a broken eye tube, broken volume control and bent chassis. The chassis was bowed where the inside corner of the heavy power transformer was inadequately supported by the surface of the chassis. This also resulted in the tone control shaft being misaligned and no longer fully rotatable. The chassis was straightened and a new metal brace installed along the plane of the top of the chassis.

A new line cord and some cracked wires were also replaced and a line fuse installed.
