## Brunswick Model 22 Chassis Refurbishment – Gerry O'Hara, SPARC, January, 2011

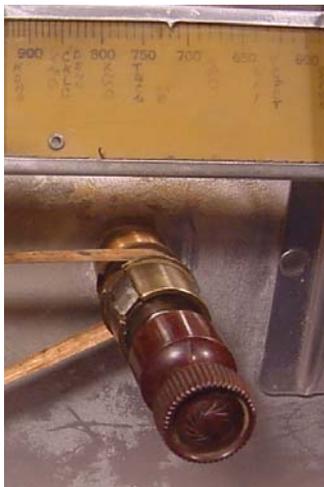
An unusual feature of this chassis is the control method – all on one shaft: tuning, concentric with the volume control (itself a variable capacitor - actually a bit of wire actuated with a rack and pinion system), the local/distance switch, and the power switch (photo, left).

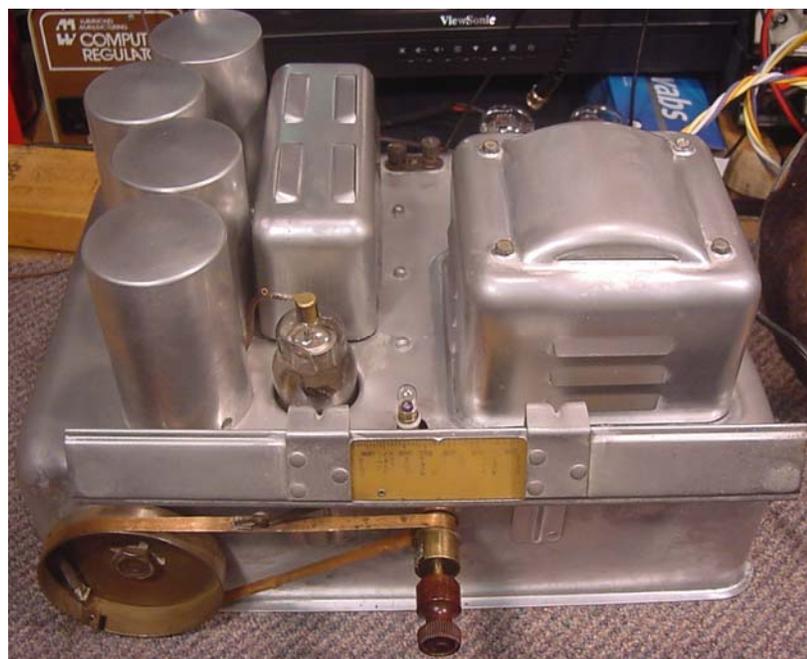
'slide rule' type (one of the earliest I have seen), driven by an actuating rod linked to the top of a pair of very robust brass bands coupled to a large wheel on the tuning gang. Another nice touch on this chassis is 'Brunswick' moulded into the each of the tuning gang rotor plate castings

(photo, right) – this was not a cheap set. All capacitors, other than silver mica types, are potted – seven in individual Bakelite cases, and another seven in a large can, all potted in coal tar.

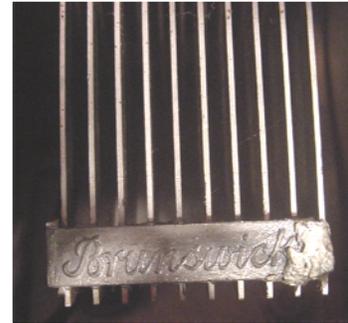
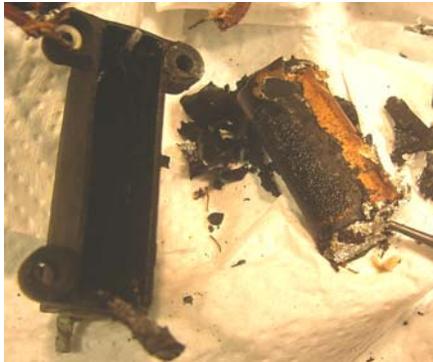
The all-important power transformer and choke both tested ok. The #24 tubes also tested ok (one a bit weak, but serviceable) and the #45s both tested very good, but the #80 had an open circuit filament and the anodes showed signs of overheating. All seven

of the Bakelite-cased capacitors were replaced (all were leaky), five of the cases were re-stuffed (photos, left), however, the two more inaccessible ones were not re-stuffed, but instead the replacements were placed discretely in the wiring. Two of the capacitors in the large can

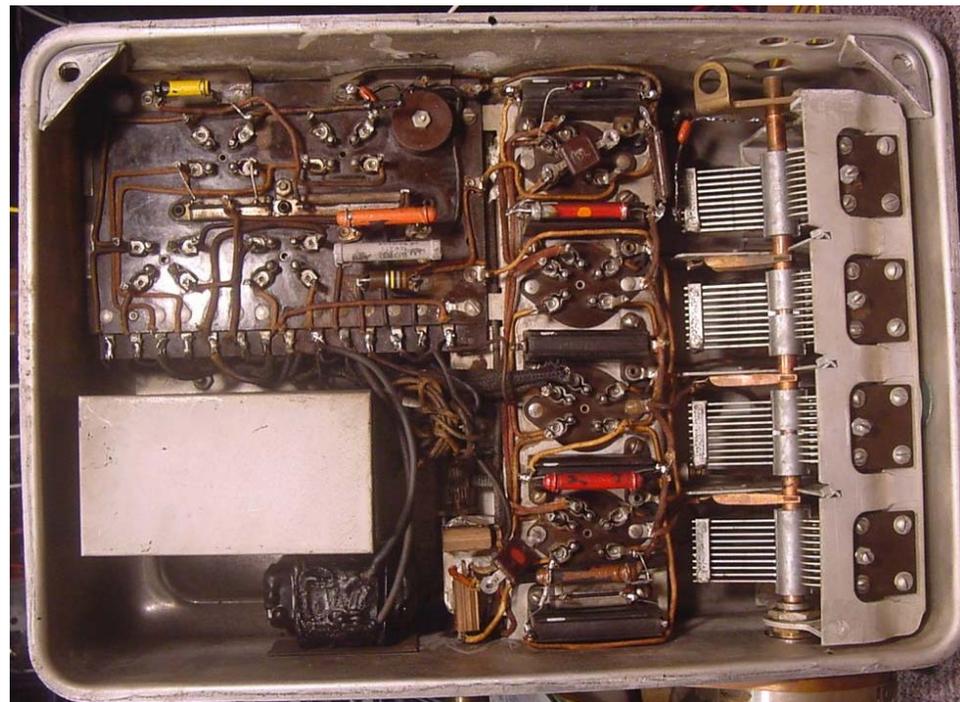
failed capacitors were the primary filter capacitor (2uF) and the choke resonance capacitor (1.4uF). The #80 rectifier had also failed – likely due to the primary power supply filter capacitor shorting out and fusing the associated wiring in the can (the power transformer primary circuit is

fused – which probably saved it when the filter capacitor failed – one fuse needed replacing). All of these capacitors were replaced external to the can and were hidden beneath the phenolic board and wiring to help preserve original appearances under the chassis (photo, above).

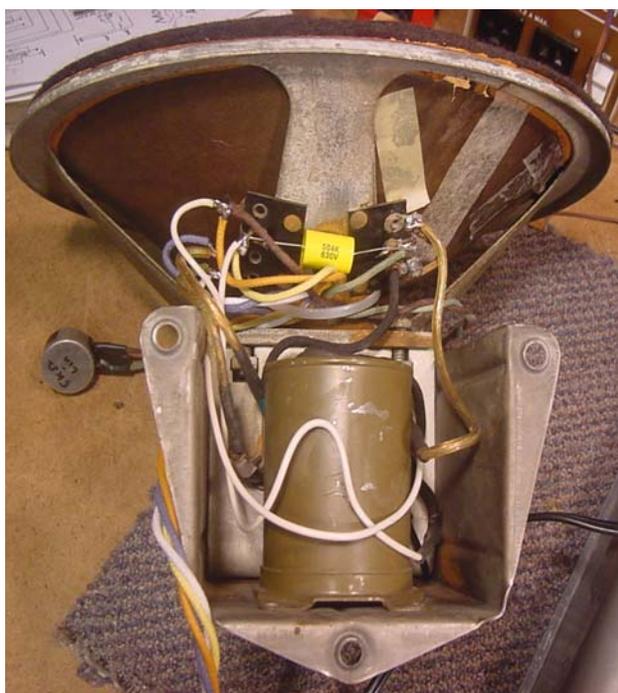
The speaker unit on this set is a very heavy-duty affair – an electro-dynamic unit that contains the tone control capacitor and wiring, field coil (with humbucking coil) and output transformer. The latter is interesting – the primary DC resistance is only 45ohms – this is because it is capacitively-coupled to the output tube anode circuit and the field coil is used as the anode load (1250ohms). The speaker unit had been re-wired at some time in the past (photo, above left) and this wiring had to be completely replaced as it was in very poor condition, along with the tone control capacitor and potentiometer (photo, above right). The speaker plug was carbonized and was falling apart – this was replaced with the base from the failed #80 tube (photo, right).

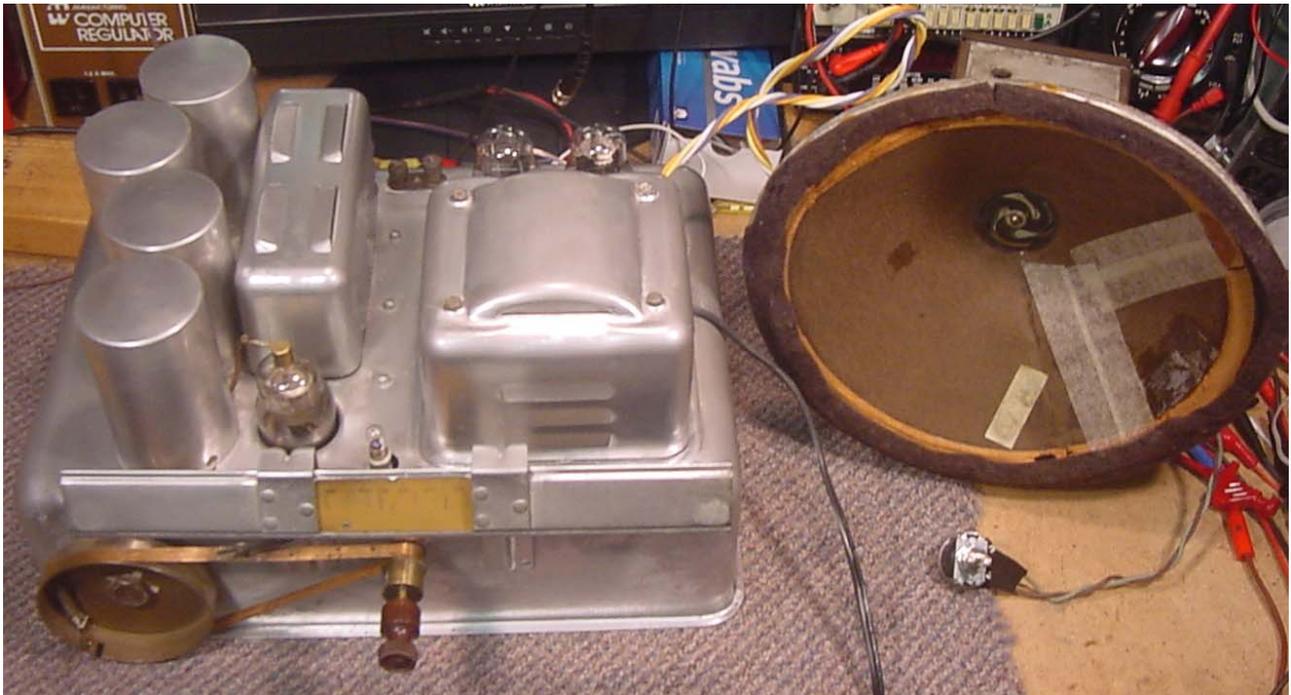
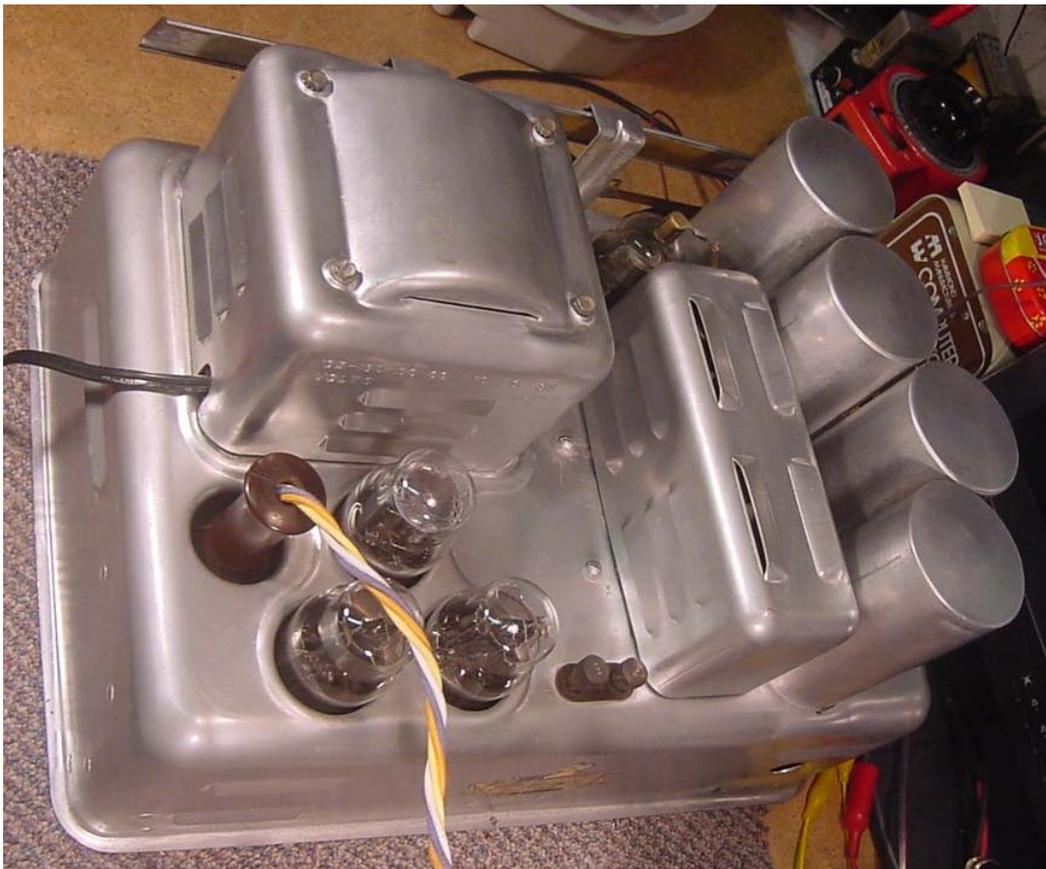
Above:  
Refurbished  
Chassis with  
speaker unit.  
Left: Rear view  
of the chassis  
showing inset  
tubes
