Restoration of a DeForest Crosley Model 870 – Gerry O’Hara

The museum finished restoring a DeForest Crosley Model 870 ('Greig') in May, 2009. This model has a Rogers Chassis Type 8M-721 fitted - a 7 tube superhet dating from the 1938-39 model year. This set was 'found' in three pieces: the chassis (rough and minus some tubes), the cabinet (rather rougher, but miraculously containing a plastic bag with the knobs and other hardware in it) and the dial glass (pristine), under a plastic canopy and lean-to shed 'somewhere in Agassiz', BC, back in 2007. It set Gerry O’Hara back \$30 - maybe a little high for a 'scrapper', but he thought it had potential and really liked the dial glass markings and shape.

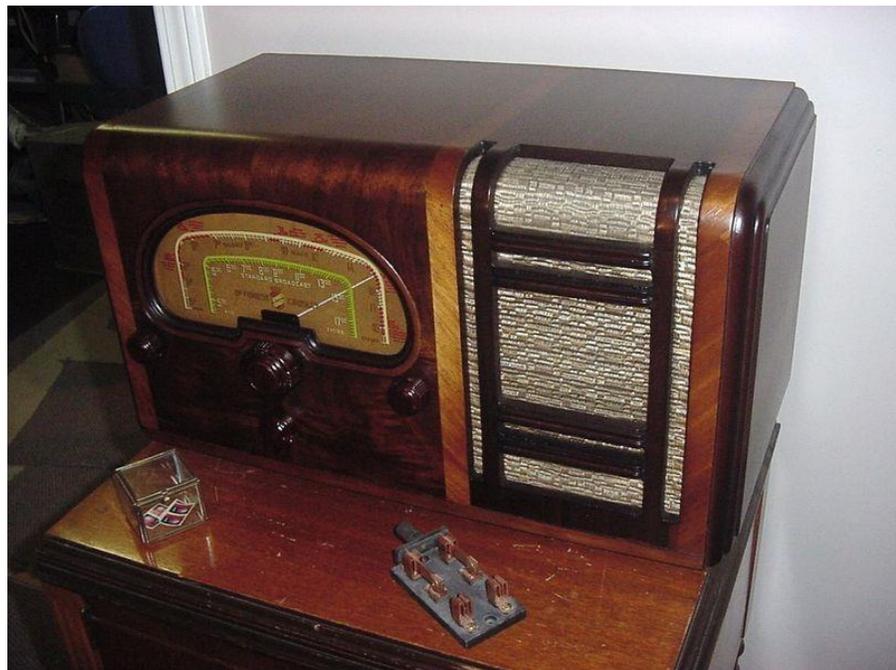
The cabinet was taken to the SPARC museum in Coquitlam, BC, where it was stripped down (by dry scraping). Water damage had warped the frame and weakened the glue, and some sections of the veneer had parted from the top of the set. The frame was re-glued and missing/damaged sections of the veneer replaced. The cabinet was then sanded with 600 grade 'wet n dry' lubricated with lemon oil, and then given several coats of shellac, each being rubbed down with super-fine steel wool.

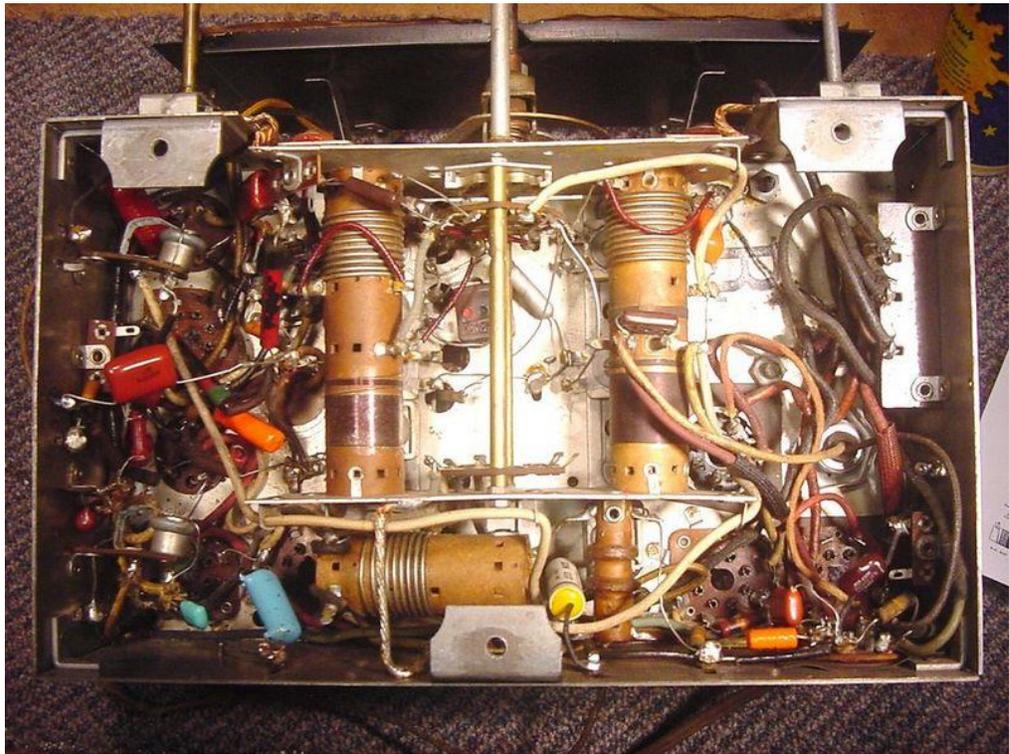
The circuit includes two bias cells (1 volt 'button cells', providing fixed bias in place of the more usual self-bias provided by using a cathode resistor and grid leak resistor), these providing delayed AGC and bias for the first AF amp in this chassis. The bias cell holders had already been modified to take

standard modern (1.5v) button cells (as used in watches and hearing aids), so these were replaced with a couple of new cells in as the ones fitted measured only a fraction of a volt. Someone had already had a go at recapping the chassis - by the looks of the replacements this had been done within the last 15 years or so - all polycarbonate or Mylar types, but strangely the electrolytics had not been replaced - these were very leaky and well out of tolerance, so these were replaced, leaving the old electrolytic can and cardboard casing above the chassis for cosmetic purposes only. Several resistors were tested and these were found to be within tolerance so all were left as found. The transformer tested ok as did the loudspeaker field coil, though the speaker wiring was frayed and had to be replaced. The missing Rogers tubes were sourced from Phil Mijo at the Canadian Vintage Radio Society (CVRS), except the two 2X3 rectifiers and the 75M. The set had a single 2X3 fitted on arrival, but locating a second proved elusive. Becoming impatient after a week or so of completing other repairs on the chassis and having the cabinet ready, fitting a couple of silicon diodes/current limiting resistors (1N4007/150ohm) as a temporary 'fix' was considered, but after some thought, the 2X3 rectifier sockets were re-wired slightly and a 5Y3 rectifier tube fitted in one of the sockets instead. Another SPARC member, Gerry Taylor, provided some 6Q7's to try in place of the 75M duo-diode-triode.

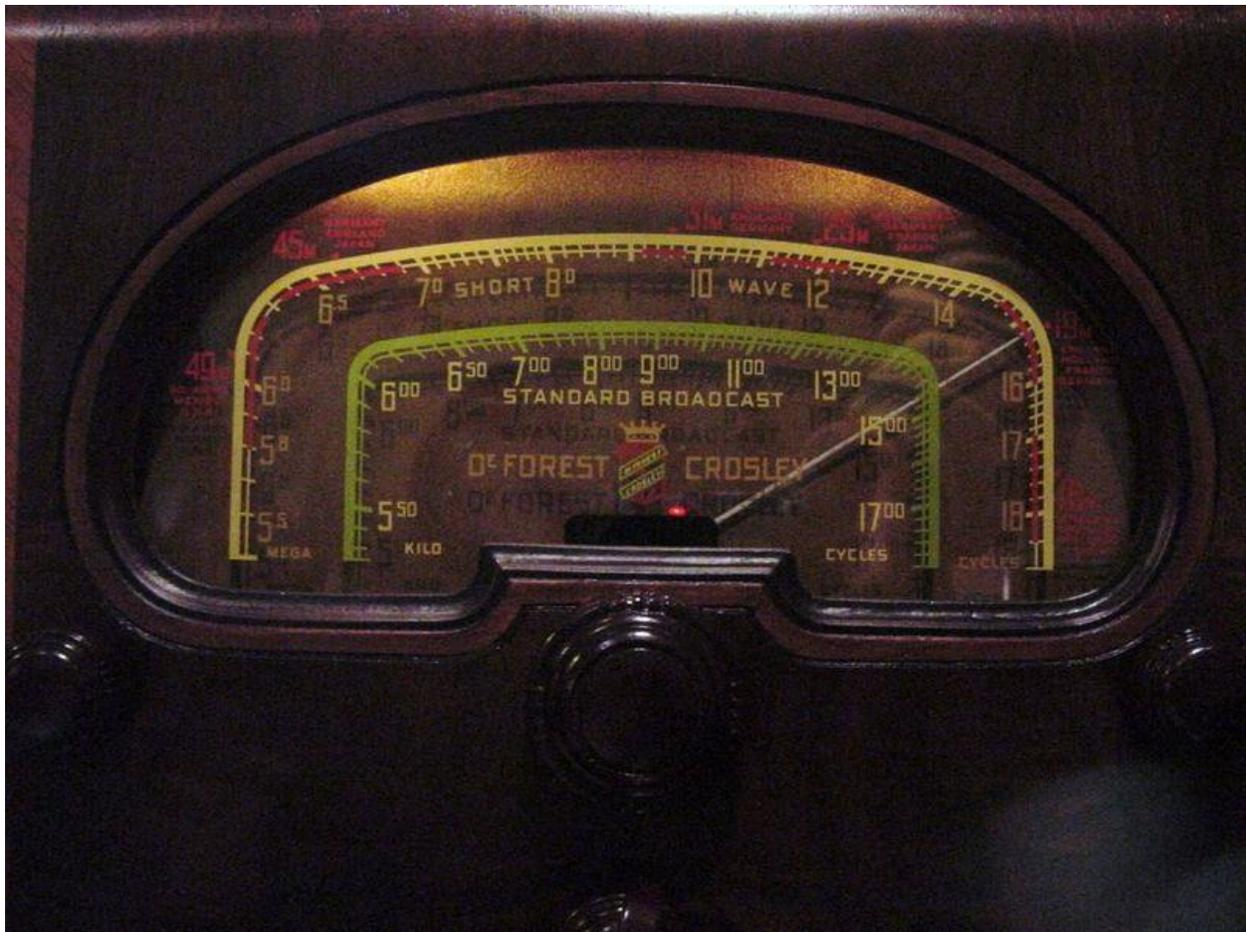
this was corrected, stations came rolling in on both the Broadcast Band and Shortwaves. A slight, but annoying hum was present when the speaker was mounted in the cabinet (inaudible when on the bench) – this was later traced to the glass-bodied 6Q7 that had been fitted - when a metal-bodied 6Q7 was installed the hum went away (figures, as the original 75M would have had a metalized envelope). While the chassis was out of the cabinet again while troubleshooting the hum, an in-line fuseholder was installed (with a 1.5Amp fuse fitted) in the power transformer primary, the rubber mounts on the tuning gang support bracket replaced (using rubber grommets of the correct dimensions), the dial glass cleaned and some heat-shrink tubing added to tidy up some frayed cloth covered wire ends on the wires going to the tube top caps. An alignment check was then carried out on the two wavebands, with only a slight tweak to the upper end of the shortwave band being needed. Four small cork pads on the cabinet feet completed the restoration.
