Eddystone Model S.750, Serial Number FB0472

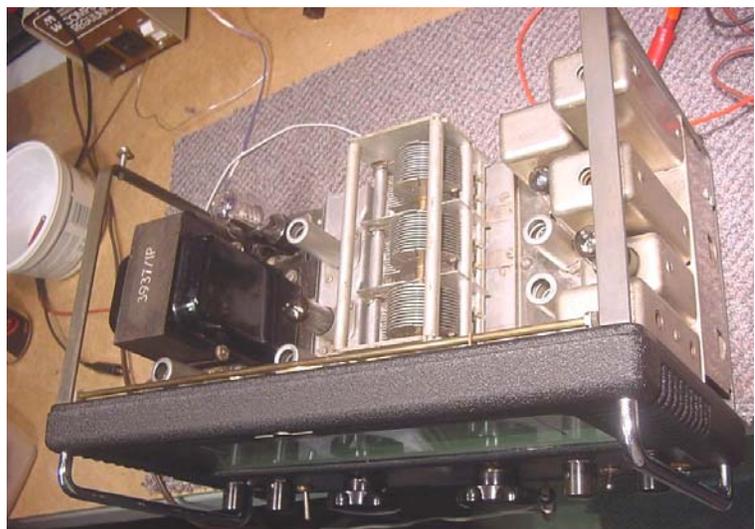
I find the cleaning process to be quite therapeutic - and this S.750 now looks 'Bathtub-fresh' again, although there is some discolouration of the scale plate under certain lighting conditions. I use

alcohol (general cleaning), acetone (solder flux residues) and lighter fluid (wax and grease), mildly-soapy warm water (dial glass and scale), Brasso (tarnished metal), and Silvo (silver plated parts), applied/removed with Q-Tips, cotton wool balls and/or several cloths.

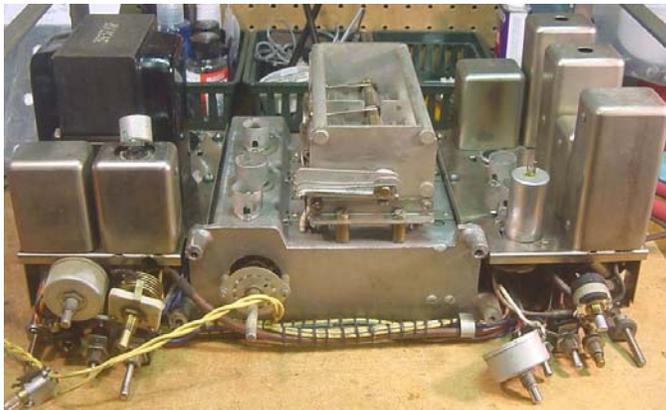
This S.750 was not working on arrival due mainly to an open-circuit HT choke, now repaired: the fault was a corroded wire internally on one of the connection posts. I found that the choke can be opened-up quite easily

by cutting the solder seal with a knife blade and then re-sealed by soldering and/or with epoxy. I re-formed the electrolytics, changed-out the dropper resistor to the VR150 voltage regulator (incorrect value fitted as a previous repair) and the cathode resistor in the RF stage (68 ohms had risen to 230ohms) and re-soldered a silver mica capacitor that had come undone in the coilbox. Other components were found to be within tolerance and tube voltages tested ok when 110v AC is applied to the set (unfortunately mains power on this side of the pond these days is between 115 and 120v, so this increases the HT voltage significantly and also adds some 10mA to the HT current draw).

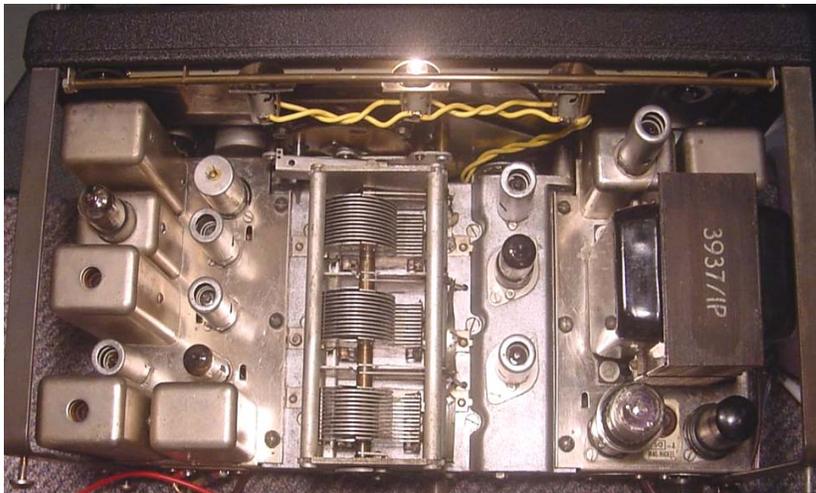
While I was aligning the set I noticed that the AGC line was going positive by a couple of volts with no signal applied to the set. This also had the

undesirable effect of increasing the HT current draw by several mA. Having checked the AGC line passive components, which were all ok, I suspected that one of the RF or IF valves could be faulty - replacing a 6BA6 (V5) in the 85kHz IF stage cured this.
