FADA 'KA' Model 42 – An 'Ultimate' TRF...

Gerry O'Hara

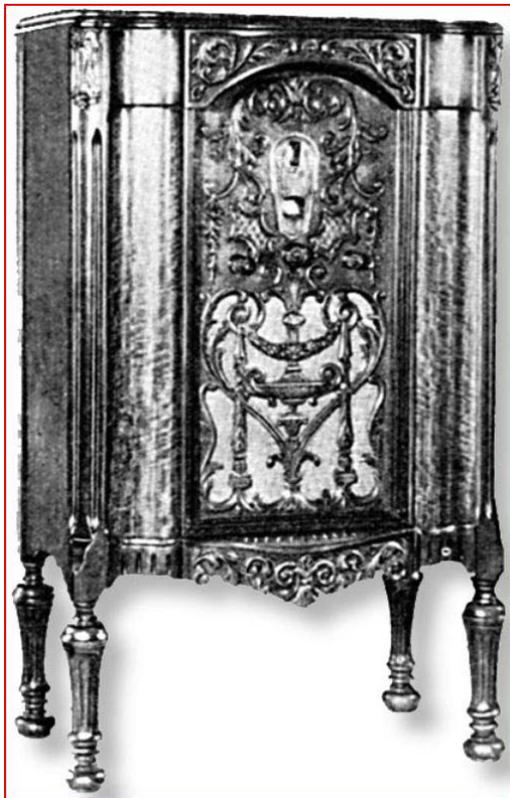
One of these advanced-design TRF's was the FADA 'KA' Model 42 (image, left), which shared the same chassis as FADA Models 41, 44, 46 and 47, the primary difference between the models being the cabinet – except Model 47, which included a turntable ('phonograph'). The 'KA' chassis was introduced in 1930 and boasted three stages of screen-grid RF amplification using #24 tubes, with a total of four tuned-circuits at RF, ganged to a single tuning control. The last of these stages was coupled to an infinite impedance detector, (a #27 tube) by an aperiodic coupling transformer, this feeding the first audio amplifier (another #27 tube), audio driver (also a #27 tube) and push-pull audio output (2 x #45 tubes) giving plenty of audio to drive a substantial 12" electro-dynamic loudspeaker. A #80 rectifier tube was

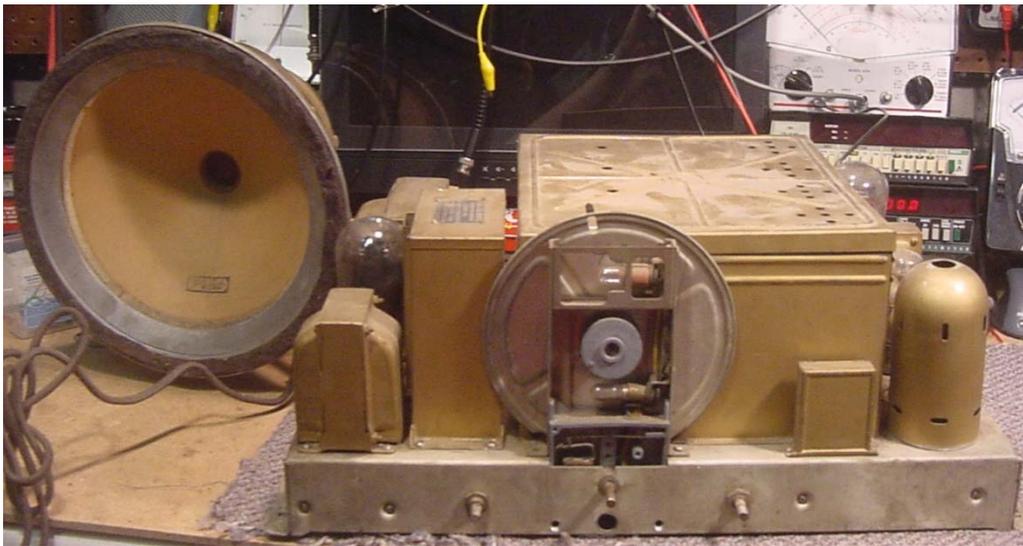
A FADA 'KA' Model 42 chassis was brought into the SPARC museum for repair (photo, left), the owner having restored the cabinet himself. The chassis was in a poor state of repair and the

4-section tuning gang – a very heavy-duty affair – was completely seized. On investigation, it was found that the end bearings were house in 'pot metal' castings that had distorted - this is a common problem with pot metal (a low-cost, low-melting point alloy), which was often used in the 1920's and 1930's for castings where strength was not a primary concern. In this case, the tuning gang had to be dismantled to allow the tuning shaft to be removed and the bearings reamed-out and lubricated. That done, another pot metal casting used to support the friction drive and 'Flash-o-Graph' mechanism was found

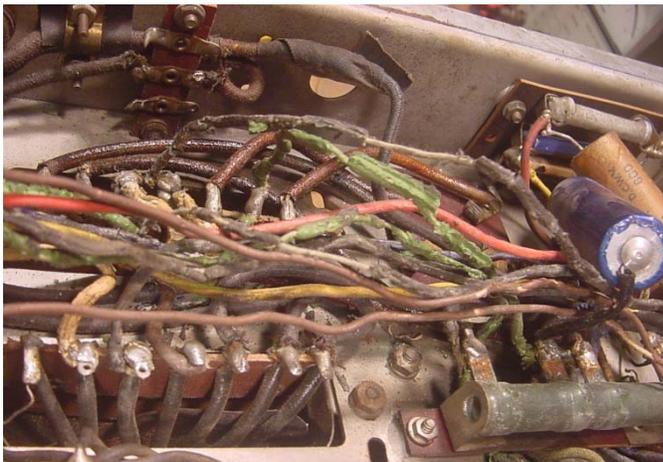
Once these mechanical repairs were completed and the chassis given a thorough cleaning, a preliminary electrical check was undertaken. The wiring was found to be predominantly rubber-insulated and unfortunately this had perished to the point that several wires in the main loom had

amalgamated and the insulation was crumbling off much of the remainder (photo, below). The first job was therefore to re-wire the majority of the chassis. Care is needed here as the tubes used in this set all have 2.5v filaments and the current draw is

substantial (many amps). Thus the loom wiring for the filament circuits had to be heavy-gauge. Period cloth-covered wiring was used for the remainder of the wiring (photo, below) and the heavy-gauge (plastic-covered) filament wiring was hidden within the loom. The 'Flash-o-

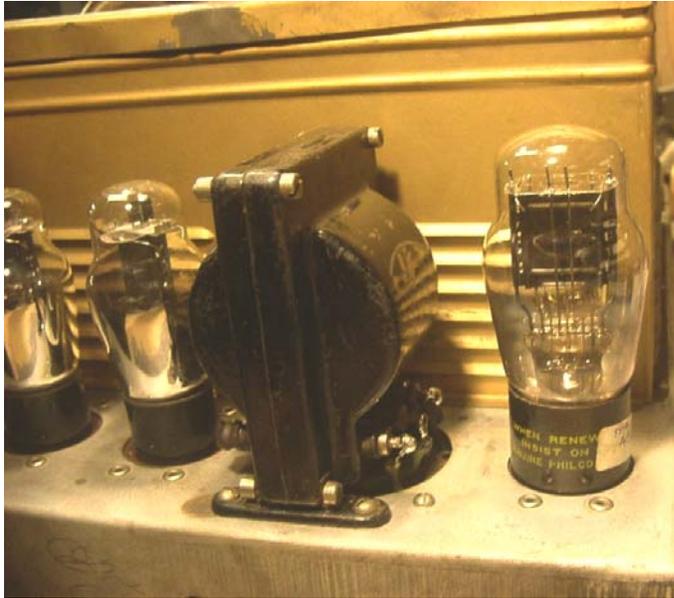
did the RF and audio output transformers, the power supply filter choke and the loudspeaker field coil. However, the audio driver transformer primary was found to be open-circuit. A suitable part was sourced from the SPARC museum stock (a late-1920's Ferranti unit) and this was fitted – a bonus of using a 'period' part was that it did not look out of place on the chassis (photo, left).

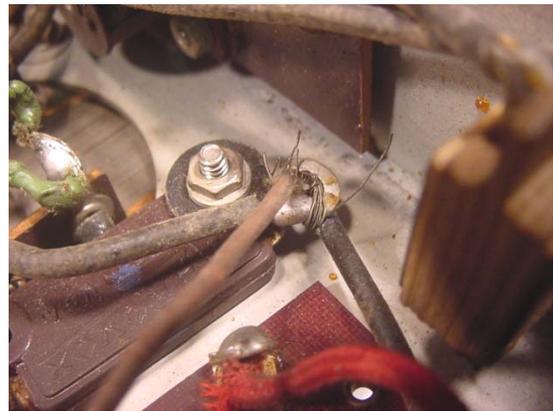
with a single 8uF electrolytic (a bit of a 'kludge') and replacement of several sections of each of the multiple 0.1uF bypass capacitors in the RF section. In addition, someone had jury-rigged a tone control in place of the local/distance switch – the wires for this were not even soldered, but simply wrapped around the grid connections of the output tubes (photo, right) - this was all removed and the local/distance switch reinstated.

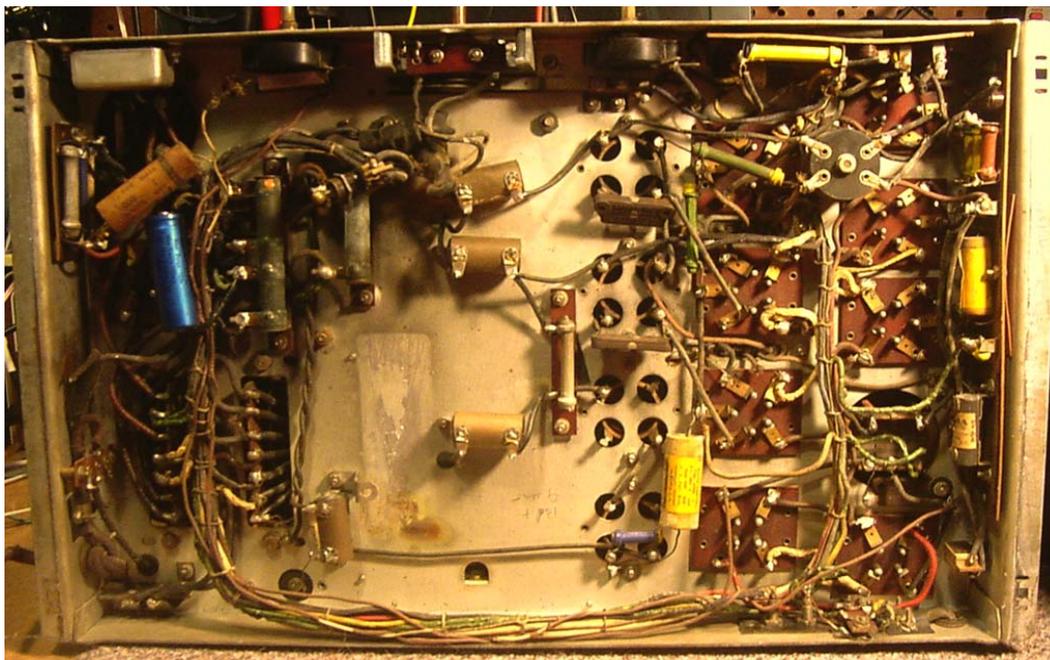
Above: below-chassis on before work started. Below: following capacitor replacement (note, several original capacitors were left in place – bridged-over - to support the new components)
