## Repair of Zenith H-723Z AM/FM Table Top - Gerry O'Hara VE7GUH

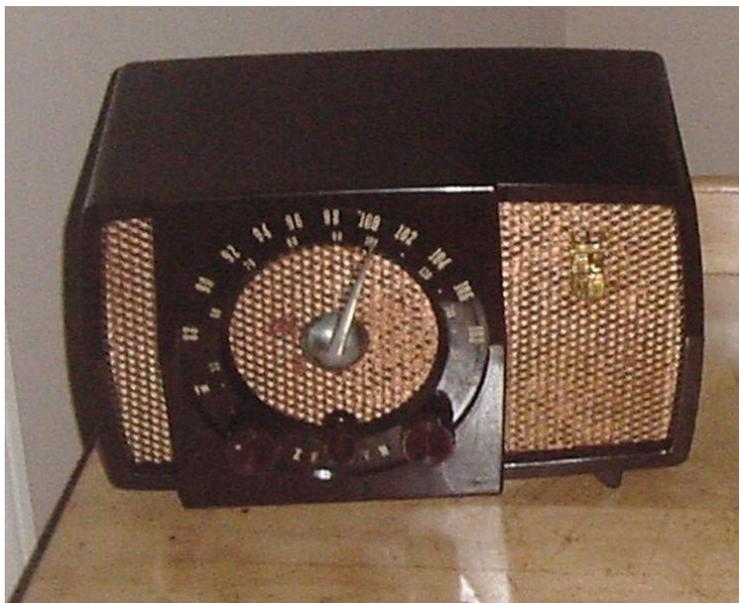
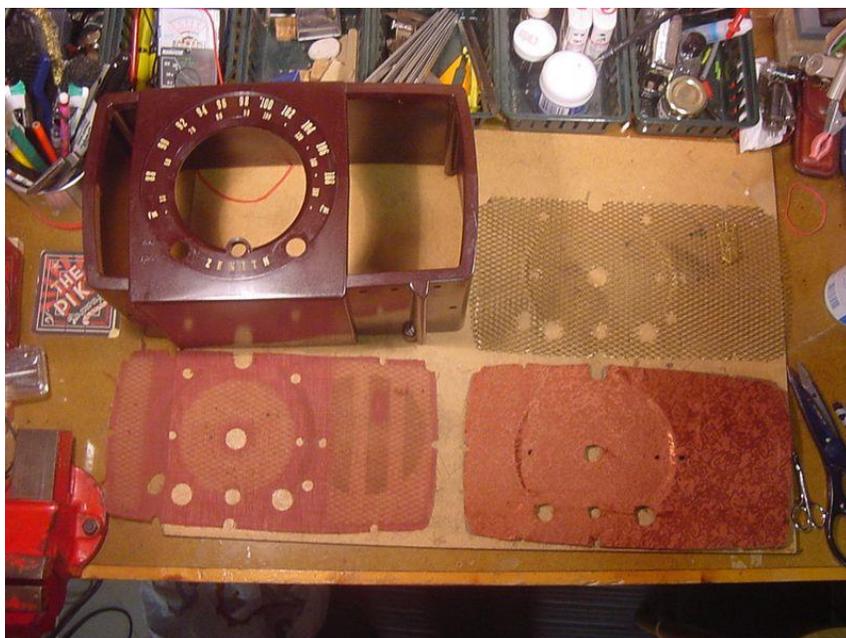
The H-723Z model (Chassis Type 7H04Z) is one in a range of similar sets produced by Zenith in the early-1950's. This particular set was introduced in 1951 and sported AM (Broadcast Band) and VHF (FM) reception, using all-miniature tubes. The H-723Z is a 7 tube plus selenium rectifier superhet designed for 110V AC/DC power. An RF stage (12BA6) is used when receiving VHF signals, with AM Broadcast Band signals being fed directly to the converter stage (a 12AT7), followed by two stages of IF amplification (455kHz on AM, and 10.7MHz on VHF) using 12BA6 pentodes, followed by a limiter stage (12AU6) on FM mode, ahead of the (19T8) discriminator (FM)/detector (AM)/AGC and first audio stage. A 35C5 output tube powered the 6 inch speaker and a selenium rectifier was deployed in the power supply. The 455kHz and 10.7MHz IF

transformers are wired in series to simplify switching between AM and FM operation.

The set as-bought did not function when purchased (not surprisingly), and it was decided to replace all paper capacitors and the selenium rectifier for a start. A silicon diode in series with a 27ohm resistor was substituted for the selenium rectifier and an extra 47uF capacitor that had been tag-soldered into the set at some point in its life was removed from the power supply and one

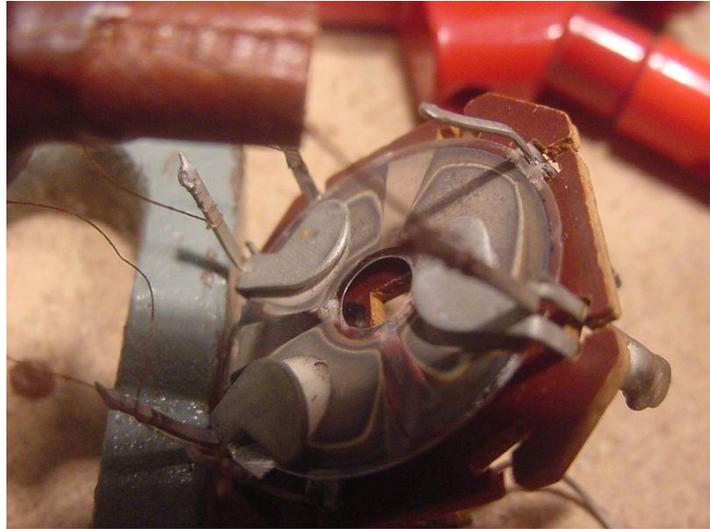
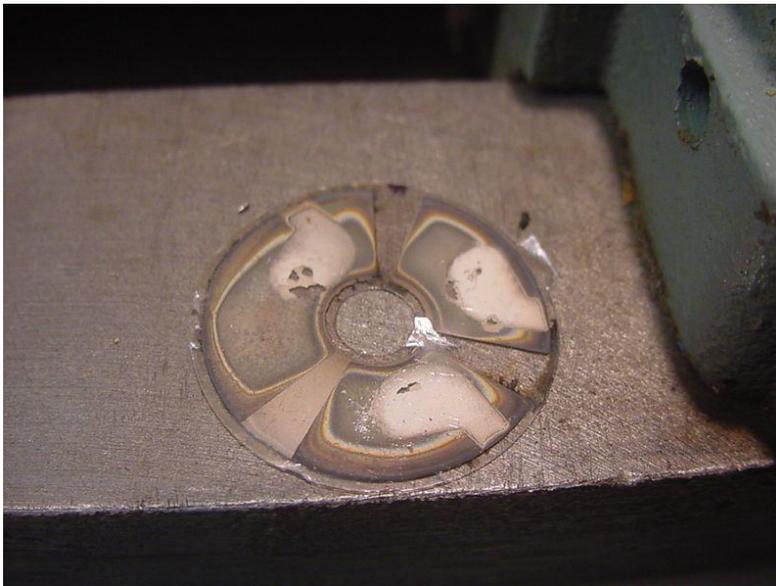
resistor was replaced that tested out of tolerance. The set was now functioning but most of the time it sounded like a thunderstorm was raging and static was discharging through the set's antenna. This is the classic symptom of the dreaded 'silver mica disease'. Of course you've been told that silver mica capacitors are the most reliable type found in vintage radios and that it is not even worth checking them. Well, they may indeed be the most reliable, but they are not infallible! Occasionally they suffer from this nasty debilitating problem. It can cause difficult-to-trace symptoms such as the loud

crashing sound found in this Zenith, but it can also manifest itself as crackling, distortion and weak signals. The effect is caused by the creeping (by electrostatic means) of the silvering from where it was

originally applied on the mica dielectric in the capacitor to where it should not be, eg. around the edges of the mica (in a discrete silver mica capacitor) or between separate areas of silvering on the same side of a mica sheet, as in the silver mica sheet/pad capacitors 'integrated' into the 455kHz IF can construction in the Zenith illustrated here. For more detail, check out [the IF transformer page at P. Pinyot's website](#).

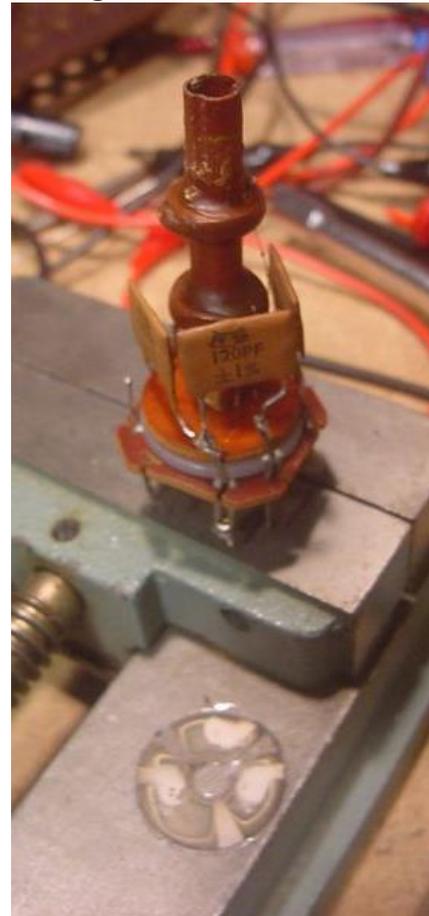
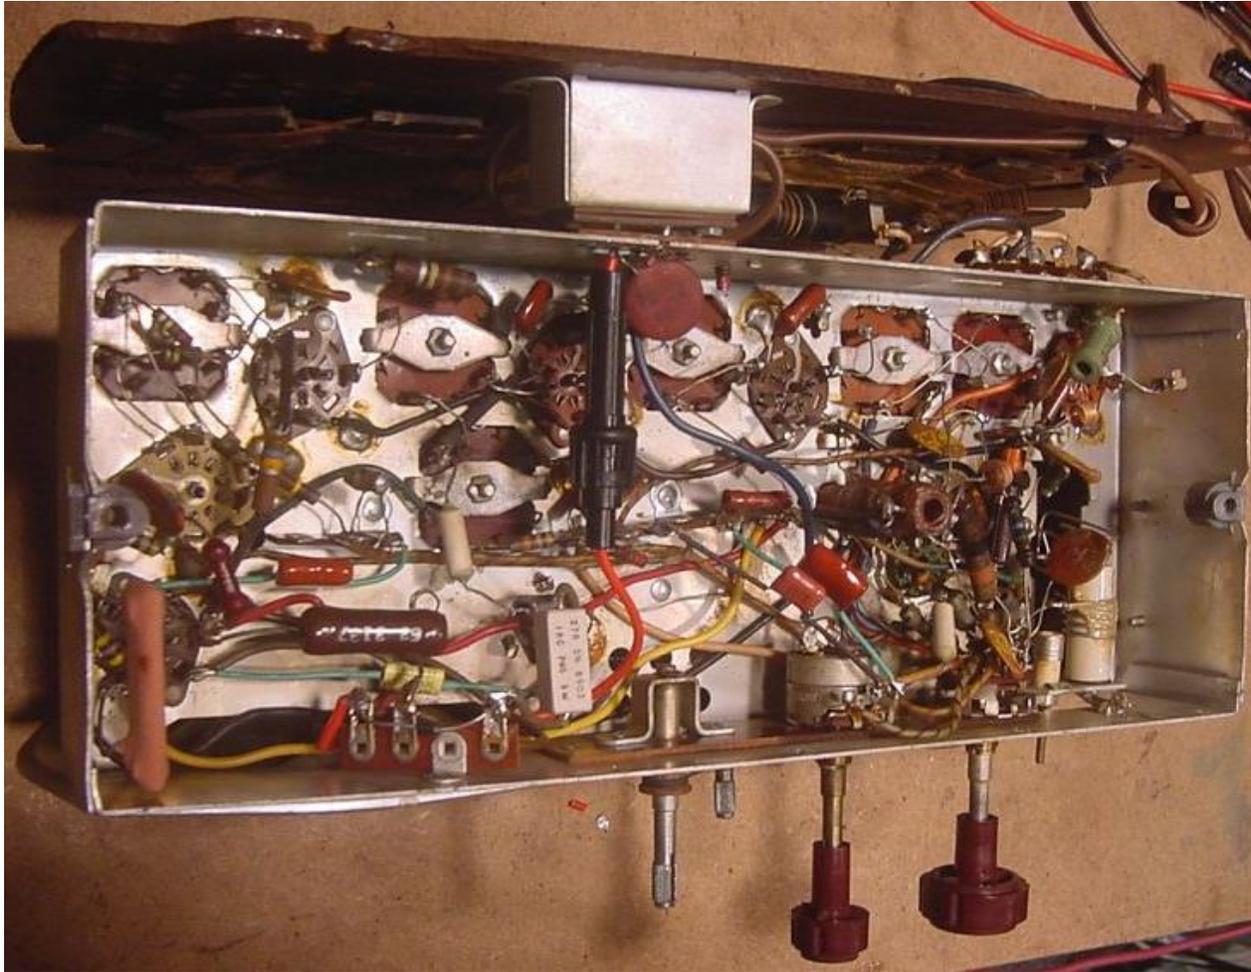
So what can be done to cure it? - naturally, there is a reluctance for the repairer to un-solder all the wiring from the transformer connections to remove the can from the chassis in order to gain access. Unfortunately, this must be done - in this Zenith, once opened, and in common with many sets of the day, the IF transformers did not contain discrete tuning capacitors, but silver mica capacitors that were integrated with the transformer

construction: a mica sheet with silvered pads on it that contacted connections in the base of the transformer housing. An initial attempt at scraping the fine silver lines away from between the silvered pads to eliminate the problem failed - although an improvement was made doing this, the fault persisted in a milder form. A permanent cure was only effected by fitting a plastic insulating washer in place of the mica plate and installing two discrete silver mica capacitors across the primary and secondary windings of the transformer. The schematic did not have values marked for these capacitors, so the coil inductance was measured and the correct capacitance value calculated to resonate the coil inductance at the IF frequency (455kHz). This came out at 120pF and after installing these, the resonant frequency was checked with a grid dip oscillator (GDO) - they tuned up like a charm.
