Restoring an RCA AR88LF – Gerry O’Hara

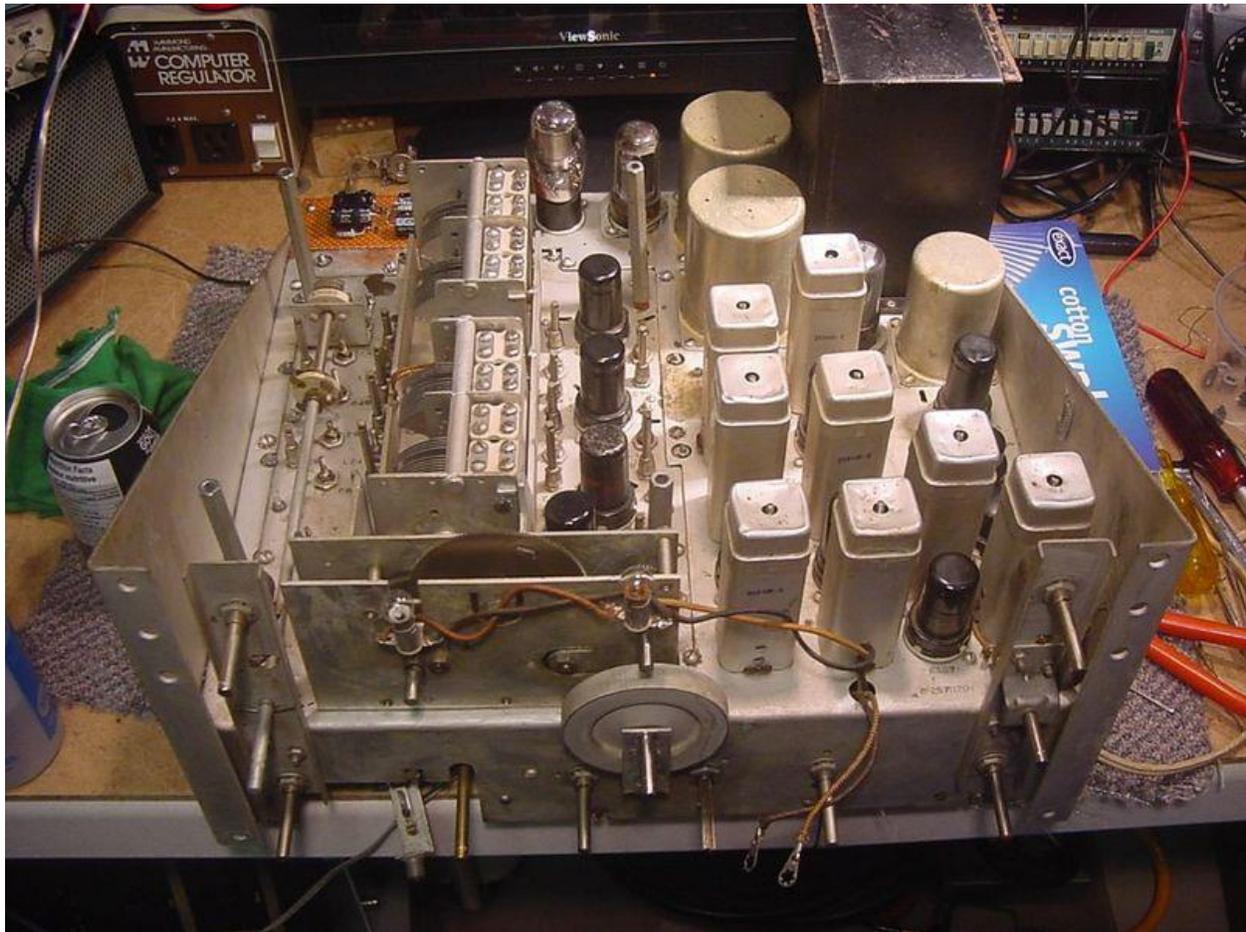
The most obvious fault with the receiver on receipt (bought from a colleague at the SPARC radio museum) was oil dripping from the case—this turned out to be from the large filter capacitor can, which is filled with PCB oil (nasty stuff—a known carcinogen—that must be handled and with caution, avoiding dermal contact, and mindful of correct disposal methods). The chassis was cleaned-up and the capacitor innards removed (3 x 4uF 550vw paper capacitors) - there was no oil left in the can, only an oily residue. The can was cleaned-up, repainted and retained for cosmetic purposes and a new capacitor bank constructed from new

electrolytics (6 x 10uF 450vw units—3 series pairs to give 3x5uF 900vw units as the HT in the radio reaches over 500v when in standby mode). Following this, the radio was cautiously powered-up and it worked first time. A few capacitors were changed (mainly as a precaution) and a recommended minor modification carried out to the AF output stage
