Re-building a Rogers Type 563 Chassis – Gerry O’Hara

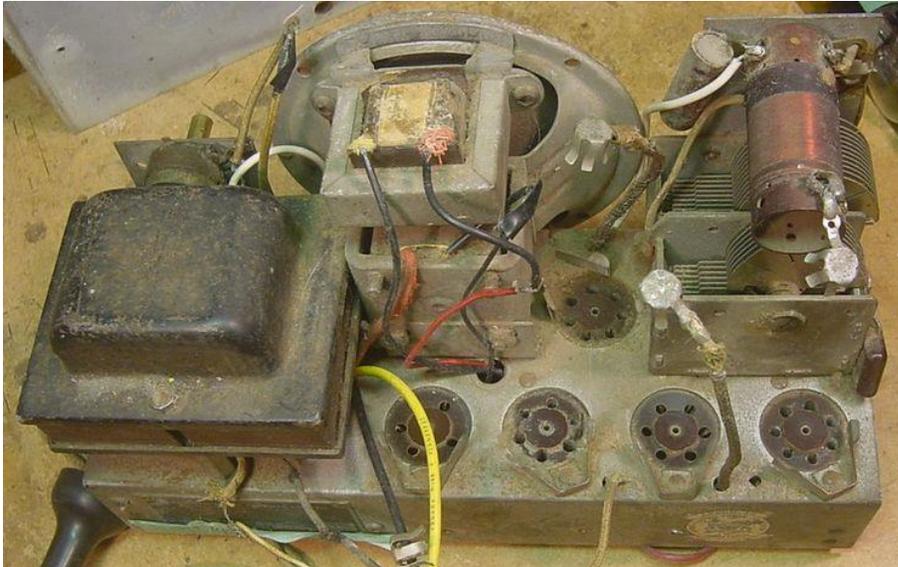
small labels made from masking tape. It was decided to strip everything out from beneath the chassis and start again with (mostly) all-new wiring and passive components. The first job was to take out the first IF transformer (the large oblong box under the chassis) to allow access to the converter and IF stages. This transformer had been riveted in place, with one rivet in a very awkward spot, resulting in some mangling of the case before it came free. However, once out, this allowed good access to the 6A7S and 88S tube bases. The two tagstrips and under-chassis wiring were then chopped-out. The two (previously-replaced) 10uf electrolytics were tested and found to be ok, so these were re-used, along with one of the silver mica caps: all the other capacitors and resistors in the set were discarded, all

either being in poor physical condition or testing out of tolerance.

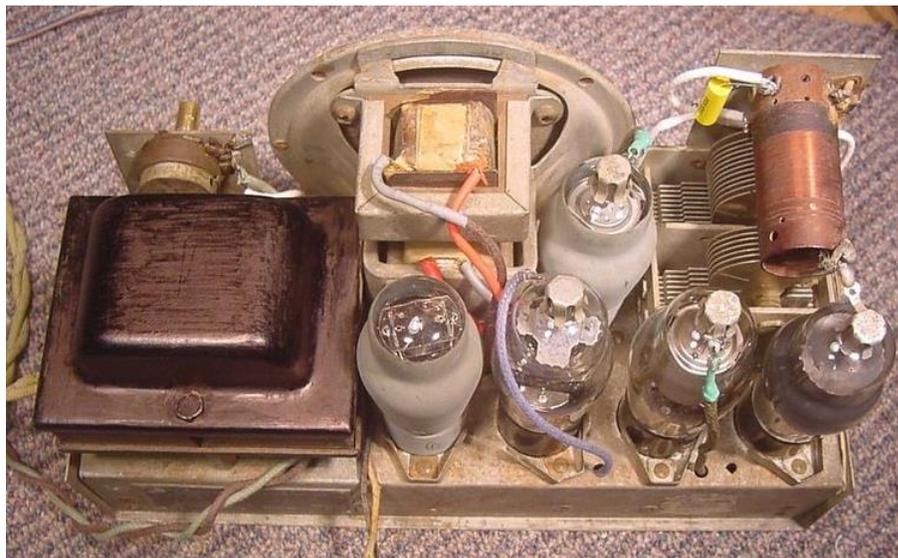
The power transformer was then tested – it worked. It has a nominal 300-0-300 volt and two 6.2 volt windings (the 84S rectifier is a 6.3 volt filament). However, it was noted that the high voltage winding was not balanced around its centre-tap, being more like 285-0-305 volts – this could either be poor tolerance during manufacture or a shorted winding. The transformer was powered-up and left running (no load) for a half hour or so and it was still cool, so it was decided to press on with

the re-build. The wires emerging from the power transformer are wrapped in what looks like bandages, however, some of this looked suspiciously fibrous, possibly containing asbestos. Not being able to remove this without dismantling the transformer, it was 'stabilized' in-situ by applying several coats of clear nail varnish.

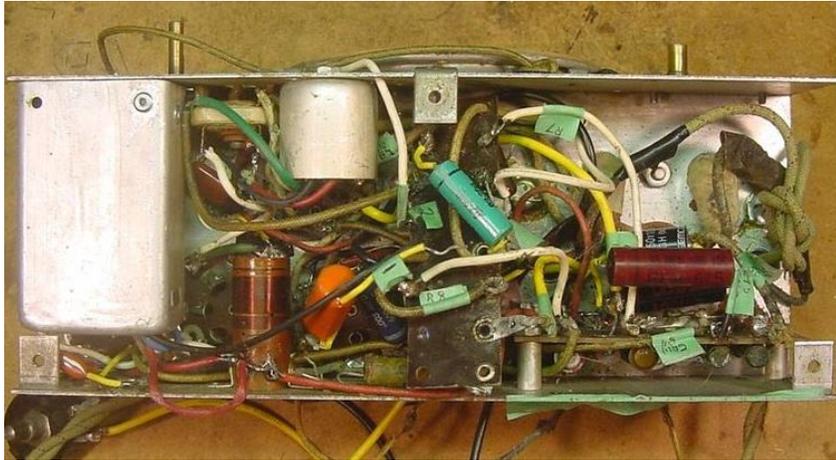
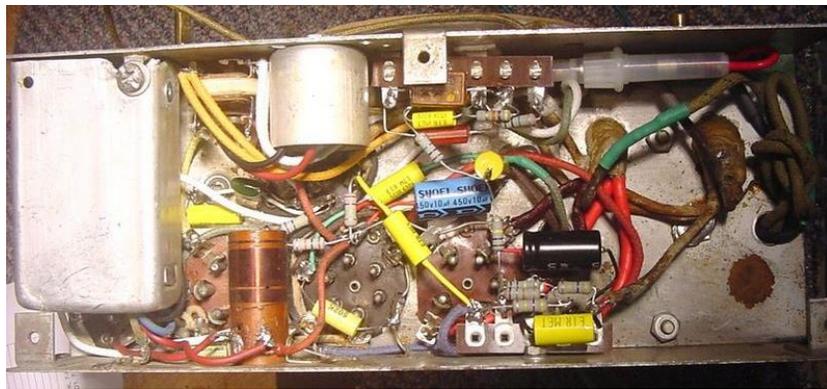
Components and re-wiring began at the front-end of the set (6A7S) and worked back towards the AF stages and finally the power supply. It was noticed that the colours on the insulated wiring emerging from the two IF transformers were incorrect – concluding that these were possibly both replacement items, this being supported by the crude way they had been re-mounted to the chassis. The secondary of the second IF transformer (the small round metal can beneath the chassis) was found to be open-circuit and this was tracked-down to the fine coil wire becoming detached from the thicker lead-out wire –

fairly easy to repair, though a bit fiddly. For expediency (rather than authenticity), it was decided to mount as many of the new components as possible directly to the tube bases, minimizing the number of wires beneath the chassis – this arrangement also makes for a more easily-understood layout when servicing in the future. Two small tagstrips were still needed however, one serving to mount the AF and AGC resistors and capacitors, the other the bias supply resistors and filter capacitors in the power supply. New metal-film resistors were used throughout, along with polypropylene, polyester or 'Mylar' capacitors, a couple of 'NOS' silver micas, plus the two 10uf electrolytics recovered from the 'rats nest' (this chassis appears not to have had can-type electrolytics fitted – unusual for an early-1930's design). The 'washing machine' wiring was replaced with new cloth-cover wiring. Heat-shrink tubing was used to tidy-up frayed-ends on the little remnant original wiring, eg. to the speaker field coil and AF output transformer, plus some of the power-transformer wiring. A 1 Amp line fuse was installed beneath the chassis as some added protection. In order not to miss replacing anything in the re-build, all the components were pre-selected from stock and placed in a 'parts bin' on the workbench, ticking off each one on the schematic as it was installed, together with notes on any replaced wiring (otherwise it is all too easy to miss connecting something up). A layout diagram was not drawn as the circuit is fairly

simple, and it was decided where things should go as the re-build went along, minimizing leads lengths and number of grounding-points. Only one of the grid leads (top-cap connections) was replaced – the others were re-furbished using heat-shrink tubing.
