Restoring a Marconi Model 142 Table-Top Radio – Gerry O’Hara

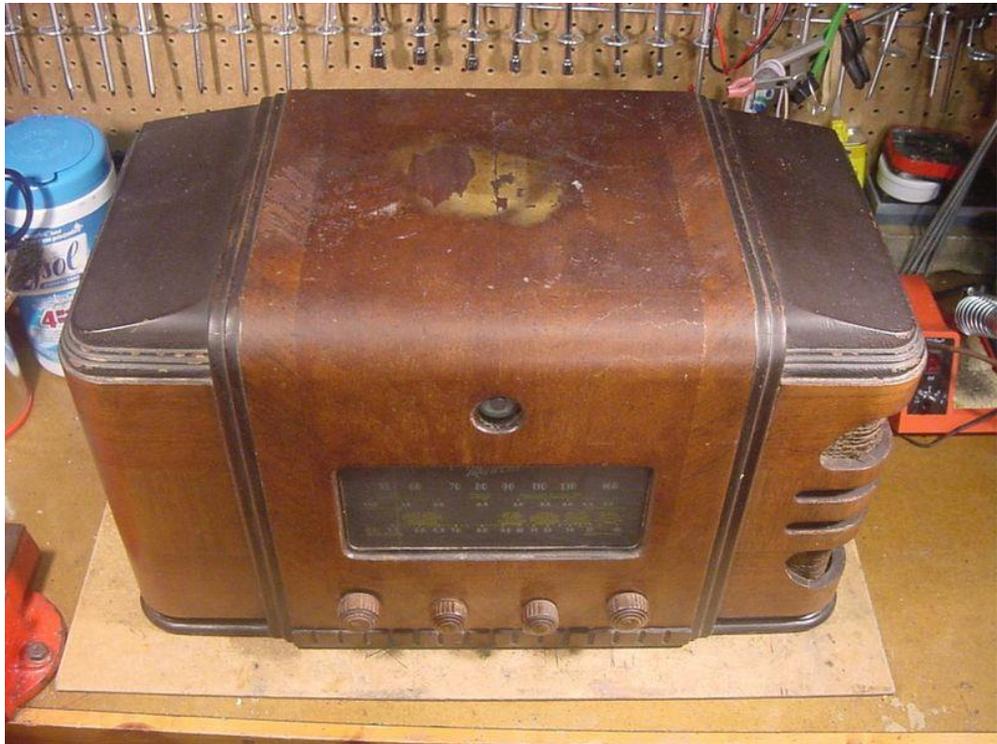
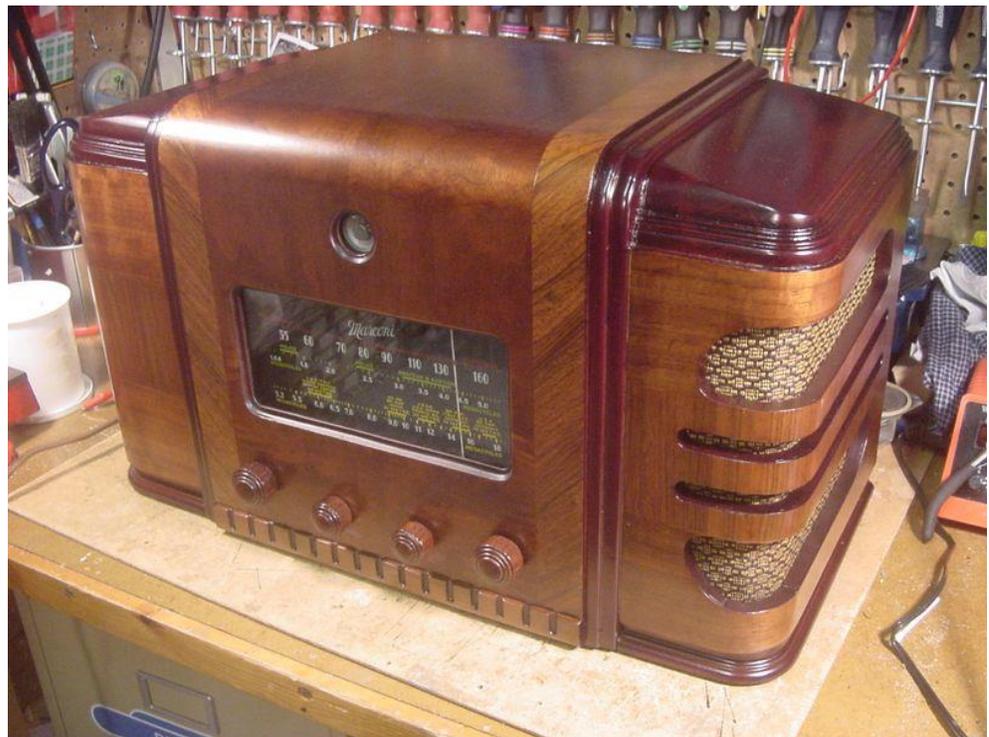
This Marconi Model 142 table-top dating from 1938 was acquired from a local second-hand store and was in rather a sorry state, with the cabinet having been the subject of long-term abuse from a plant pot or similar. This had resulted in bad discolouration and warping of the veneer on the upper surface, with some areas becoming detached from the underlying plywood. The chassis was also in a poor state: rusty and with many tired-looking components. Even so, the set looked like it had potential and those Marconi dials look just great when lit-up...

The chassis and speaker were removed and the cabinet taken to SPARC as a Sunday afternoon project there for a few weeks. The old lacquer was painstakingly scraped off (no stripping chemicals were used), the detaching and

warped veneer glued down, and the surface prepared for re-lacquering by sanding with lemon oil as a lubricant. Three coats of shellac were then applied, each being rubbed-down with super-fine steel wool. The cabinet was then masked, exposing only the shoulders, front trim strips, flutes in the lower front panel trim strip, magic-eye/dial cut-outs and the edges of the loudspeaker cut-outs.
