Restoration of a Zenith Transoceanic 'Bomber' Radio – Gerry O'Hara, April, 2011

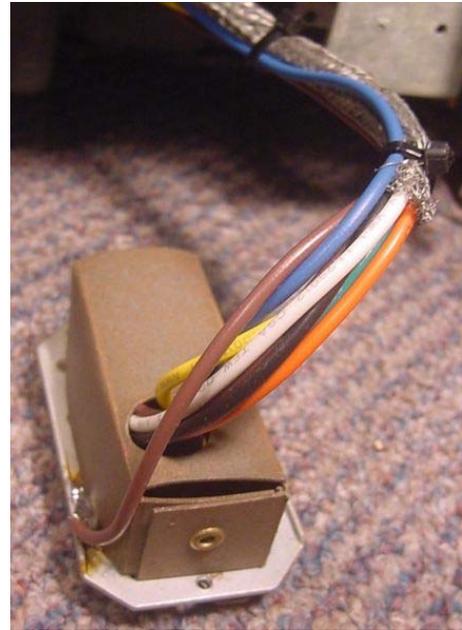
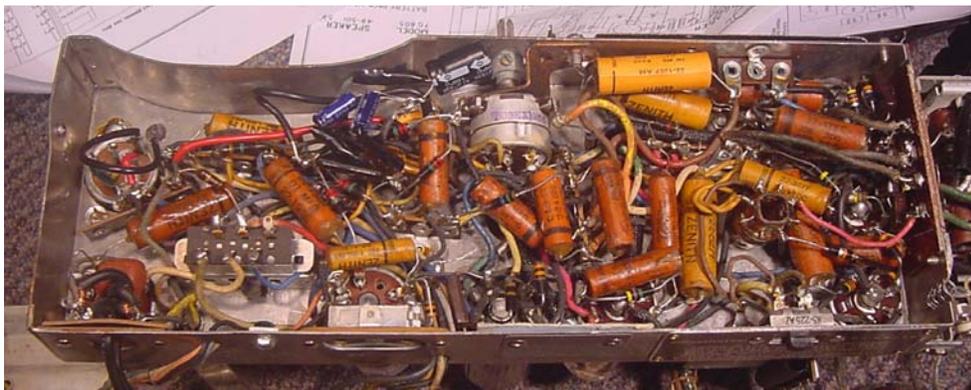
Given the obvious wiring problem I decided not to try powering-up the set, and subsequent inspection under the chassis revealed some more wiring horrors beneath - some hardened rubber insulation as above the chassis, plus some (yellow) insulation that had turned to a soft chewing gum-like consistency. Other rubber-insulated wiring and cloth-covered wiring was intact. The degraded-insulation wiring was replaced with new stock PCV insulated wire - that in the tone switch wiring loom being a bit of a challenge, as several wires passed through a metal screening braid. The trick here was to use the existing wires to pull the new ones through, having first removed two of the originals to make some room in the sleeve (lots of hardened rubber bits falling out in the process) - photo, right. The wiring insulation problems sorted out, the next job was to check the power supply circuits - safety first! Inspection showed that someone had been there before me and had replaced all the electrolytics: given the selection of types present I figured that probably at least a couple of episodes of electrolytic replacement had occurred over the years. The original two above-chassis (can) multiple electrolytic capacitors had both been replaced, and three small (newer) units had been fitted beneath the chassis (photo, below). Closer examination revealed that a 200uF unit was being used as the primary power supply filter capacitor (instead of the original 40uF unit) and that an error had been made in wiring two of the smaller electrolytic capacitors beneath the chassis - one of the low-voltage units being wired to the HT line... why this had not failed in use is a mystery. This error was corrected and all the electrolytics tested - there was some leakage present and the ESR readings were on the high side but they were left in place for the time being. The radio had been fitted with a new line cord at some point in its history, complete with a polarized two pin plug - the polarization was checked and found to be correct.

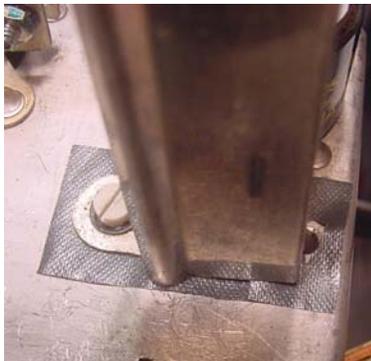
100v AC, some noise was heard on the Broadcast band, but tuning around revealed only one station that was coming in very distorted and with a strong modulation hum. With 115v AC applied, things were no better, so I started to undertake some critical voltage checks, finding some wayward ones in the process - I suspected that that some of the (original Zenith) paper capacitors were leaky. After testing a couple and proving this was indeed the case, it was decided to replace all (19) of these with new stock plastic-film capacitors for the sake of performance and reliability (photo, above). While I was undertaking this replacement work I also checked the resistors - all but one tested were within 20% tolerance: the faulty one was a 1.8kohm carbon composition unit in the HT feed. This was replaced with a 1W metal film type and the power then re-applied. The set was much better now, with more sensible voltages present throughout and several stations coming in strongly on the Broadcast band, but a strong modulation hum was still evident - a bit puzzling with all paper capacitors replaced and the electrolytics testing reasonably ok. I bridged over the electrolytics with known good units and the modulation hum persisted. Sometimes a mixer tube with a heater-cathode short can produce this effect, so the SPARC tube vault was raided for some Loktal tubes. I could not find a 1LA6 but a couple of 1LC6s were located (this tube is a good match) and these were tried - still the modulation hum persisted. After a couple of frustrating hours of further checks, the cause was finally revealed as the 'Candohm' resistor in the power supply, which was acting as a capacitor when heated-up, placing an AC voltage onto the tube heater circuit. Instead of replacing this with separate high-wattage resistors, the Candohm unit was retained, but isolated from the chassis with a teflon washer and nylon screw

(photo, above). A minor amount of residual hum was then cured by replacing the can electrolytics with new ones installed beneath the chassis. The wave-change switches and the tone control switch bank were then cleaned with De-Oxit. A listening test indicated that the 1st AF tube was microphonic, so this was changed out.

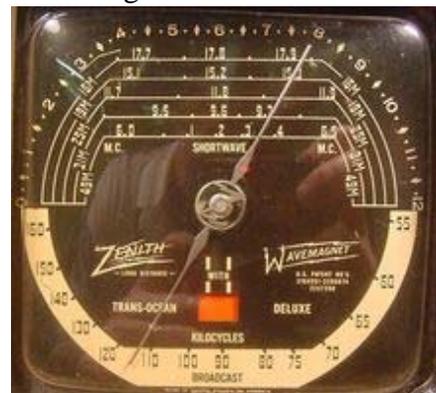
The sets alignment was then checked - not too far out, but enough to warrant a full re-alignment. The IF alignment was undertaken with the chassis out of the cabinet and the RF alignment with the chassis re-installed. Adjustment of the local oscillator and mixer trimmers can be done easily on this model by removing the escutcheon around the band change

switches. The set was found not to be working on the upper short wave bands (above around 12MHz). A weak local oscillator tube was suspected and so this was replaced with a tested 1LE3 tube from SPARC stocks. This done (and the fault cured), the upper bands were re-aligned and the set was then soak-tested for around 8 hours and found to be working well on all bands. The dial cord was found to be slipping intermittently and a little powdered rosin was rubbed onto it to effect a cure.

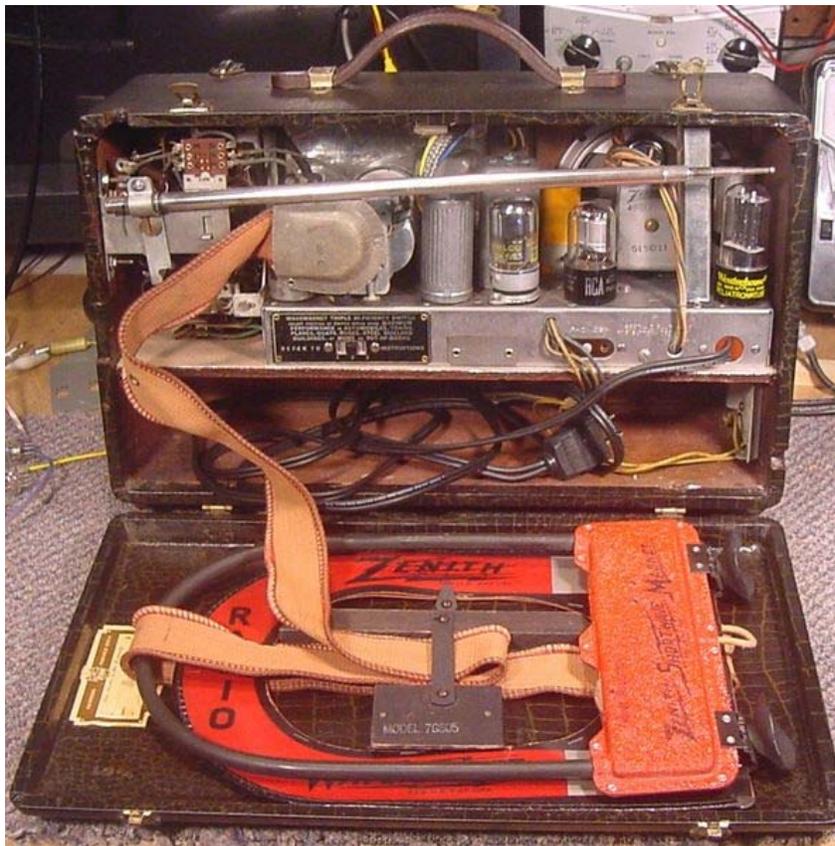
The TO has two inbuilt antennas: a loop ('Wavemagnet') and a telescopic rod ('Waverod') – photo, left. When the Waverod aerial is rotated into the upright position, the 'Wavemagnet' is automatically switched out of circuit. In this example, the mounting plate for the Waverod had become loose and the locknut securing the antenna was missing. This assembly was cleaned, re-secured with a new locknut and tested ok. That done, the set was given another soak test, receiving Radio Havana Cuba, Radio Australia and China Radio on the Waverod – not bad in my basement workshop! Broadcast band
