## Restoring a General Electric 'Color Radio' Model K-106 – Gerry O'Hara

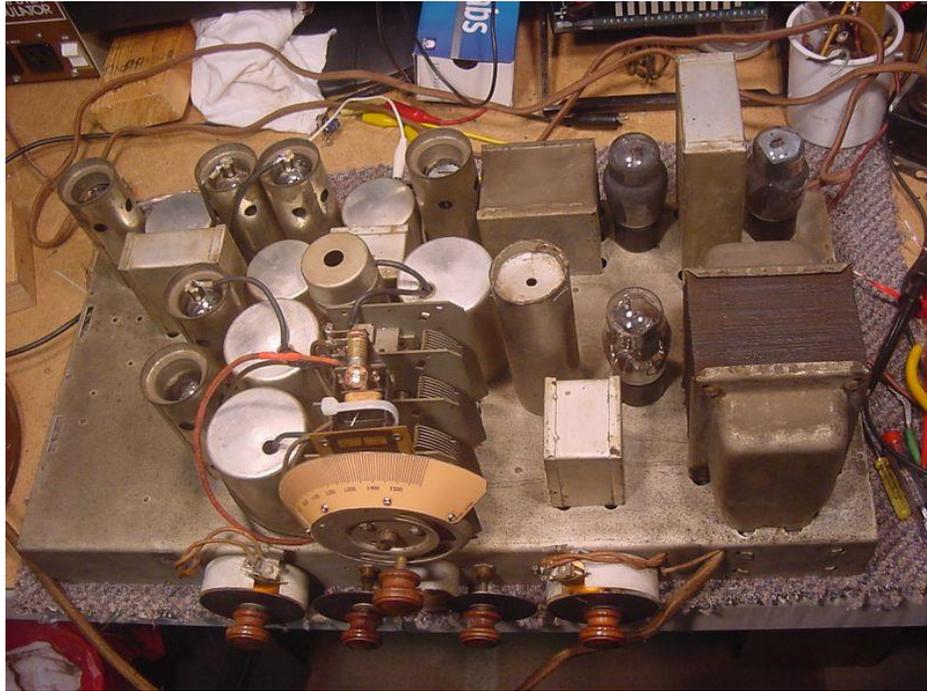
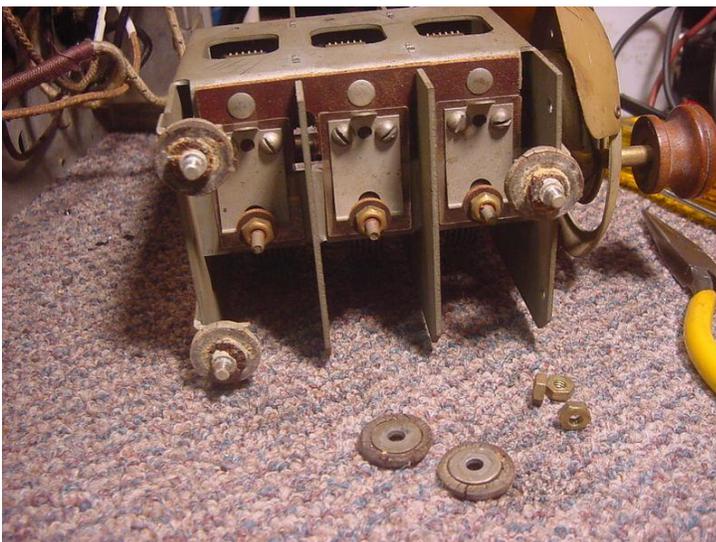
On arrival, the chassis looked very 'tired' and very dirty, with many loose and frayed wires, ancient sticky-tape covering poorly-soldered connections and crumbling rubber insulation on top-cap (grid) wires to several tubes. The chassis bore the scars of some previous repair work – many decades old judging by the components used. Where to start?

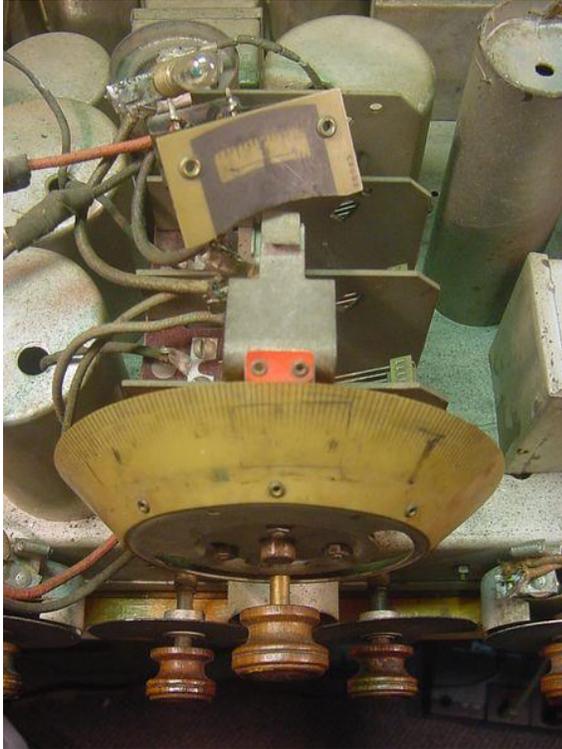
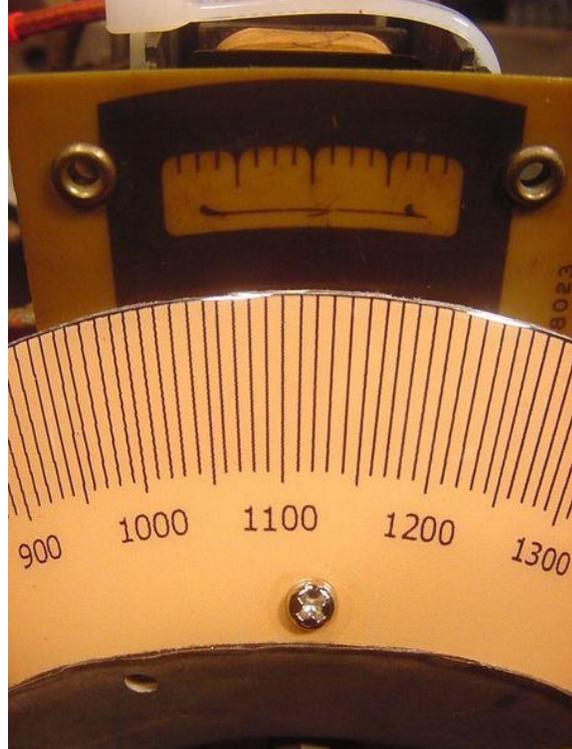
installed in the power transformer primary (2A fuse fitted). The translucent dial was very worn and a replacement had been purchased – this was fitted. The tuning meter was sticking and the needle was

bent – this was carefully straightened. All controls and the tuning gang contact points were cleaned with De-Oxit. Finally, three

dial bulbs were replaced – time to see if it worked...
