# Repair of a Marelli Assab Receiver – Brent Hilpert

(photos by John Sarembo)

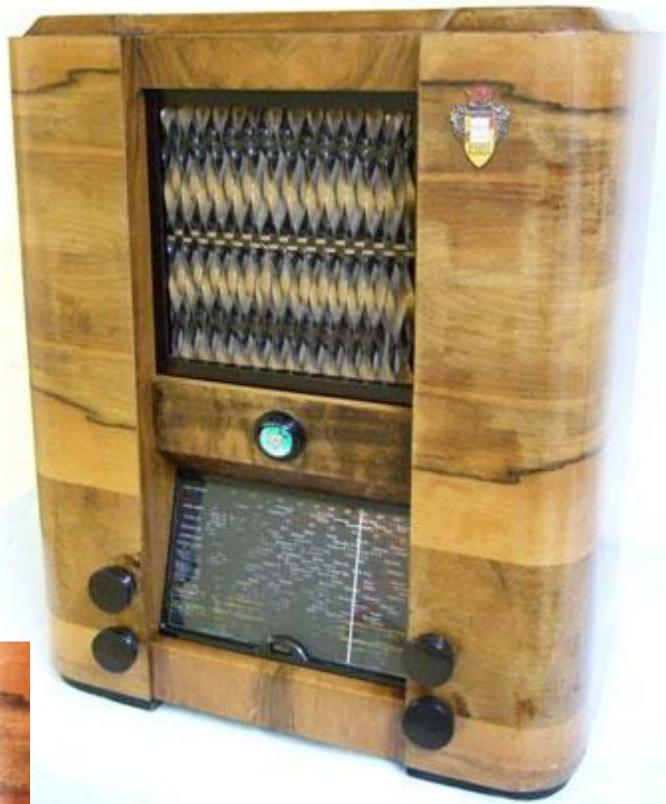
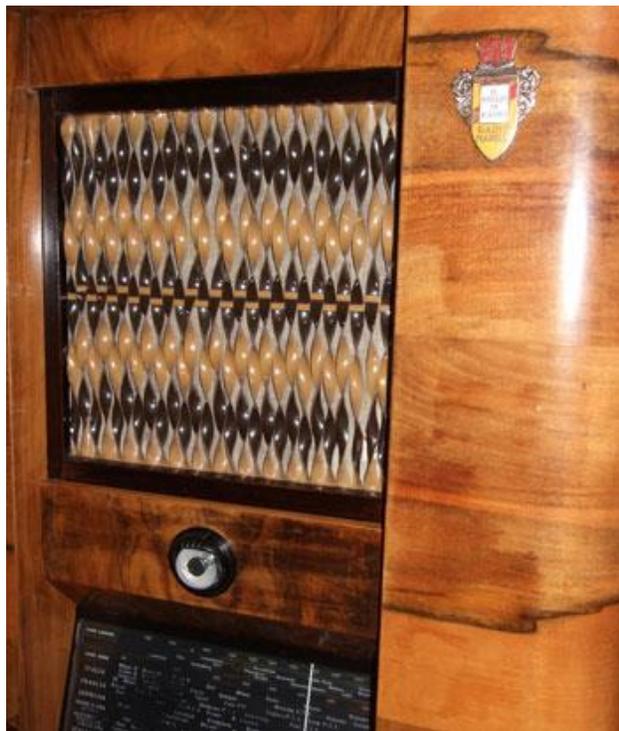
This receiver was brought to SPARC by a customer for repair. The cabinet style was immediately recognisable as being unusual for North America and looked more European. Sure enough, it turned out to be an Italian radio: a Marelli Assab from around 1938.

- Although this is an Italian receiver, the tube complement is fully North American. Apparently this is a result of a licensing deal Marelli had with an American tube manufacturer (RCA?).
- The audio output tube is a hefty 6L6 leaving the unit capable of producing a room-filling sound level.
- The tone control is not the typical resistive type, rather it controls both a variable capacitor between the first audio and audio output as well as rotating the primary coil in the 1st IF transformer to change the coupling.
